Technical Bulletin # 1153

Transmission: *AW55-50SN (AF33-5)*

Subject: *2-3 Flare or Bump*

Application: *Volvo C70, S/V40, S/V60, S/V70, S/V80*

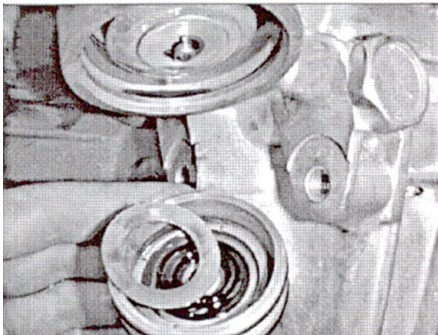
Some Volvo models with the 5-speed AW55-50SN (AF33-5) transmission may have a bump or flare on the 2-3 shift. Some owners may also complain about a harsh 4-3 downshift. This can be caused by a broken washer on the B4 band servo cover. See Fig 1. A new cover assembly (30651771) is available to correct this concern.

Fig. 1 Broken Washer in B4 Band Servo Cover

Install the new band servo cover. No relearn or re-flash is required for this repair. Test drive and make sure no other concerns are noted.

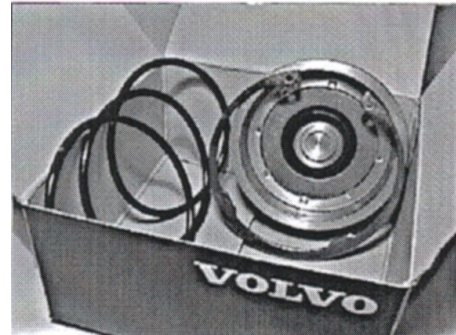
Fig. 2 New Band Cover with Washer Assembly

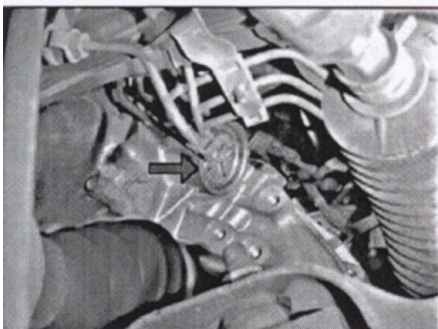
Fig. 3 Clean area around Servo Cover and Snap Ring

Use care when removing and installing the band cover. See Fig. 3. Pry the cover inward. Clean the area around the snap ring and spray penetrating oil to help free parts. See Fig. 3. Remove the snap ring, servo cover and servo. See Fig. 4.

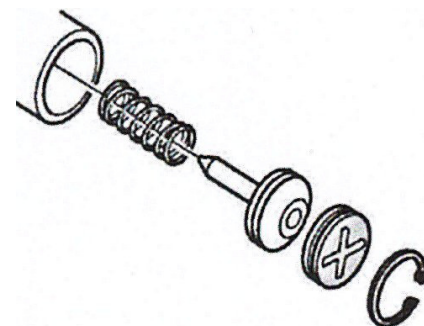
Fig. 4 View of B4 Servo Assembly
