by Lance Wiggins
members.atra.com
www.atra.com

Shift Problems Traced to Injection Pump

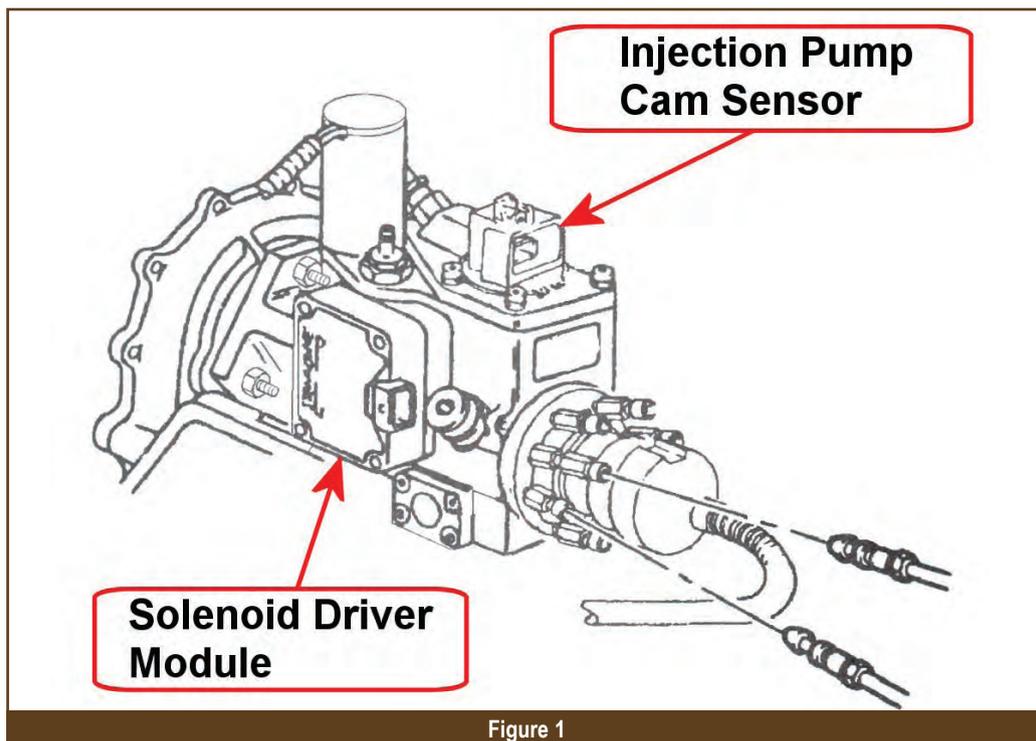
Figure 1

Unfortunately it wasn't that easy. In this case the same symptom was caused by the Pump Cam Optical/Fuel Temperature sensor. This sensor is mounted on top of the injection pump. According to General Motors, the Injection Pump Cam signal is an optical sensor that receives a 5-volt reference signal (Figure 1).

As a quick test we decided to get the vehicle running and then disconnect the Pump Cam Optical/Fuel Temperature sensor. Then we drove the vehicle; the problem was gone, so we replaced the sensor. The Pump Cam

Optical/Fuel Temperature sensor comes with the injector pump.

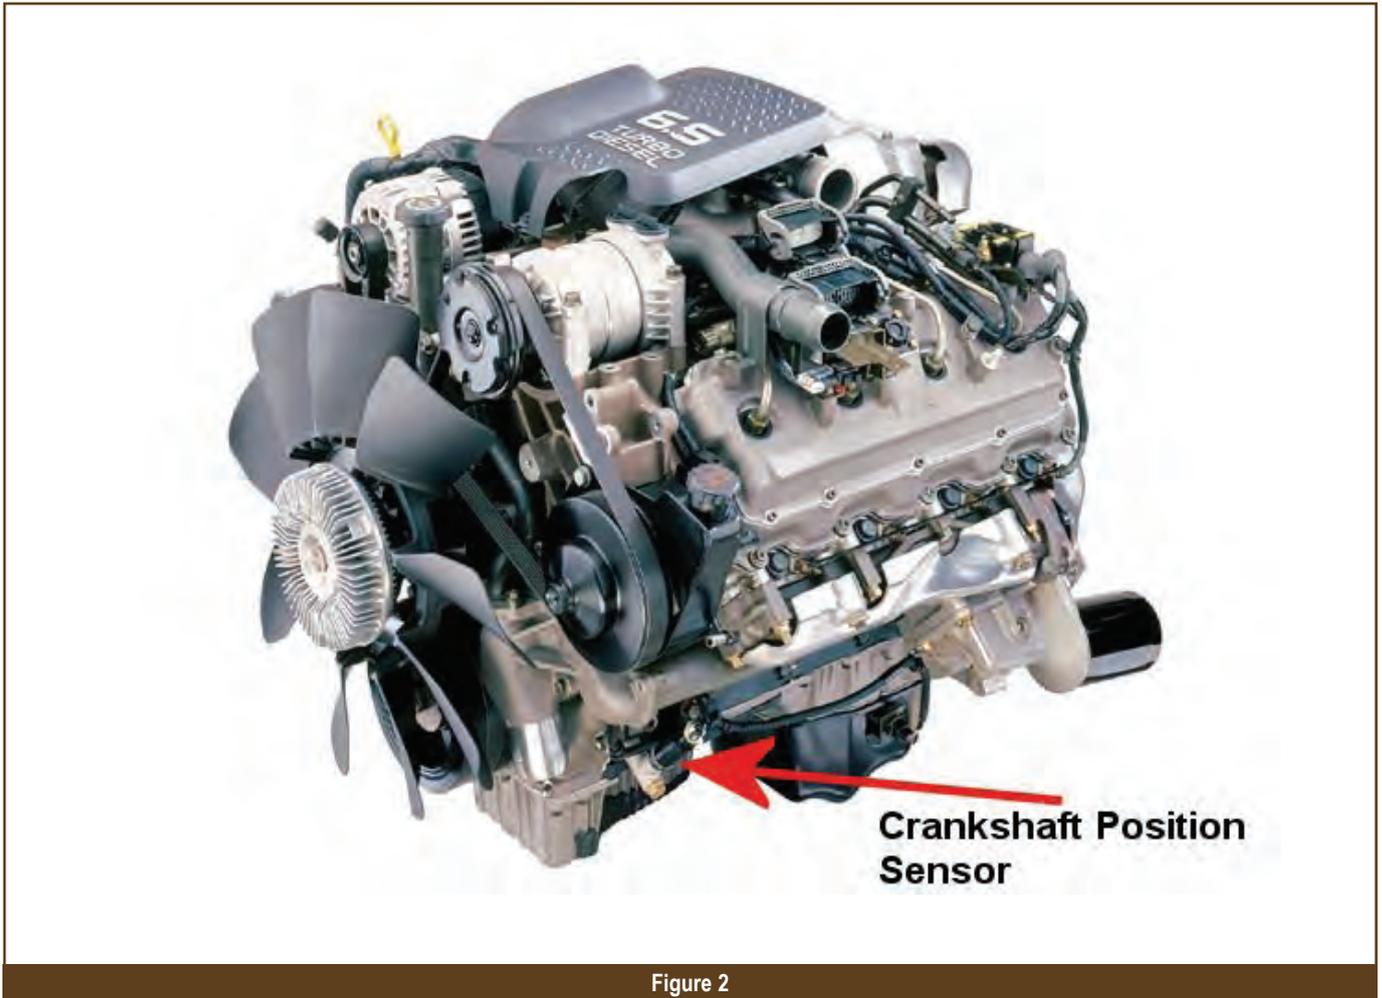
Figure 2

This signal allows the PCM to measure fuel injector pulse ring RPM and position, which is used to control fuel injection timing on start up. The PCM also compares this signal with the Crankshaft Position (CKP) sensor for diagnostic purposes (Figure 2).
