# VALVE BODY PROBLEMS with Toyota's

by Pete Huscher members.atra.com

U660E, U660F, U760E, and U760F

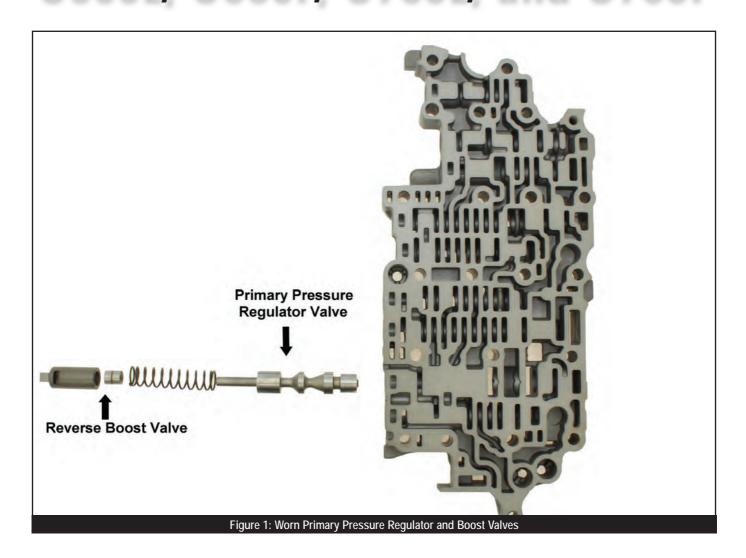
Delayed or harsh engagement may be caused by a worn primary pressure regulator valve and bore (figure 1).

Continuous modulation of the primary pressure regulator valve and reverse boost valve can cause premature valve, bore, and sleeve wear. If you find excessive wear in the primary pressure regulator valve and bore or in the reverse boost valve and sleeve, repair or replace the valve body.

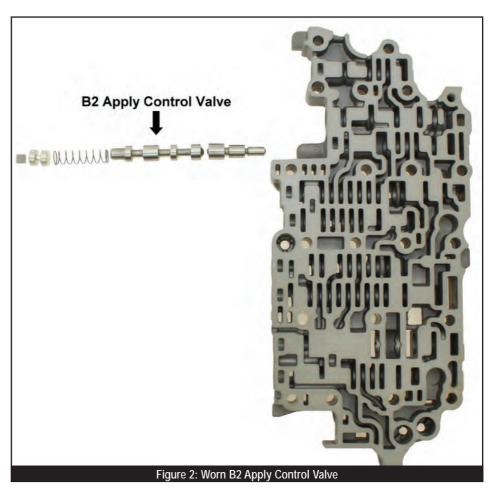
A delayed reverse, no reverse, or slipping in reverse may be caused by a worn B2 apply control valve or bore (figure 2), or a worn B2 control valve or bore (figure 3). Continuous modulation of the B2 apply control valve causes premature wear of the valve body bore.

If you find excessive wear in the B2 apply control valve and bore or the B2 control valve and bore, repair or replace the valve body.

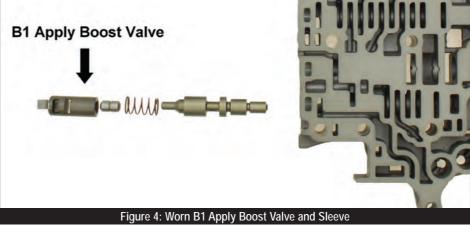
Erratic 1-2 and 5-6 shifts or a burnt B1 brake may be caused by wear in the B1 apply boost valve or sleeve (figure 4). If you find excessive wear in the B1 apply boost valve and sleeve, repair or replace the valve body.

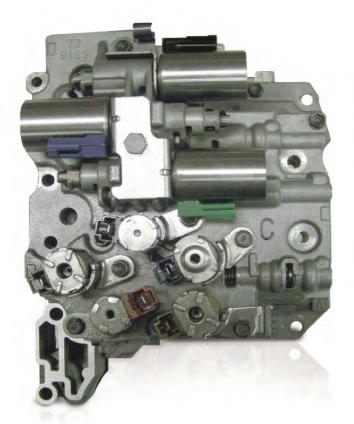
Erratic shifts, lockup problems, and burnt clutch components may be caused by worn valve body end plugs (figure 8). Worn OEM end plugs may allow line pressure and SLT pressure to leak from around the valve body bores. Installing

O-ringed end plugs during every valve body repair should correct these problems.

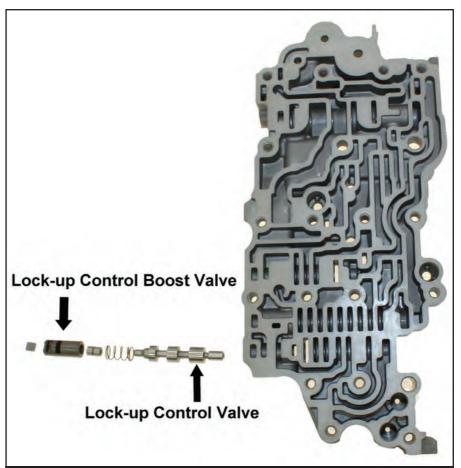
Figure 9: Worn Lock-up Control Boost Valve and Sleeve

TCC apply and release problems, TCC slip codes, transmission overheating, and torque converter problems may be caused by a worn lockup control boost valve and sleeve (figure 9). This wear may cause the lockup control valve to stroke on or off prematurely, causing erratic TCC operation. Repairing the lockup control boost valve and sleeve may correct erratic TCC operation.

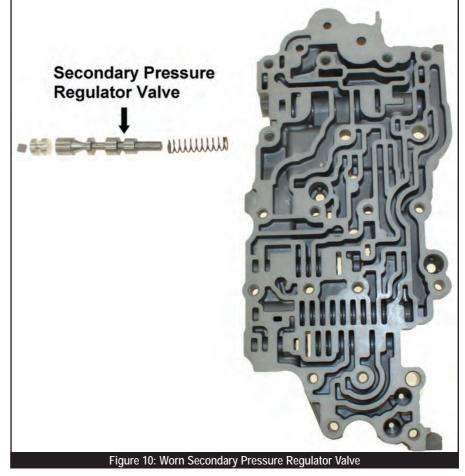
Lube problems, bearing or bushing failures, and transmission overheating can be caused by a worn secondary pressure regulator valve or bore (figure 10). Excessive valve or bore wear at the solenoid modulator valve will cause EPC oil and balance oil pressure to leak, reducing lube flow. Repairing the solenoid modulator valve and bore will usually correct this condition.
