# **Technical Seminar 2002**

# *Automatic Transmission Rebuilders Association*

# Ford

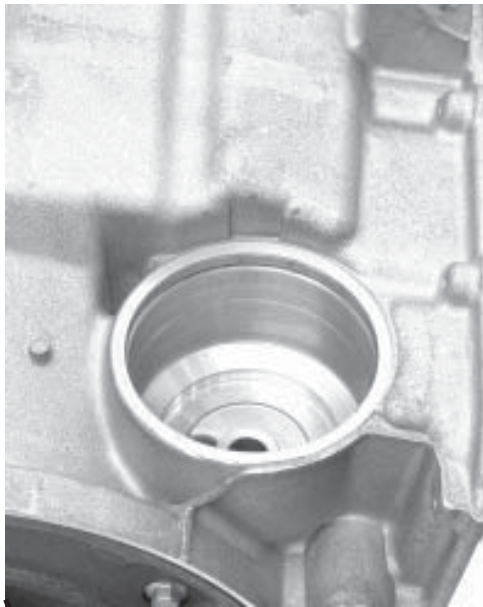
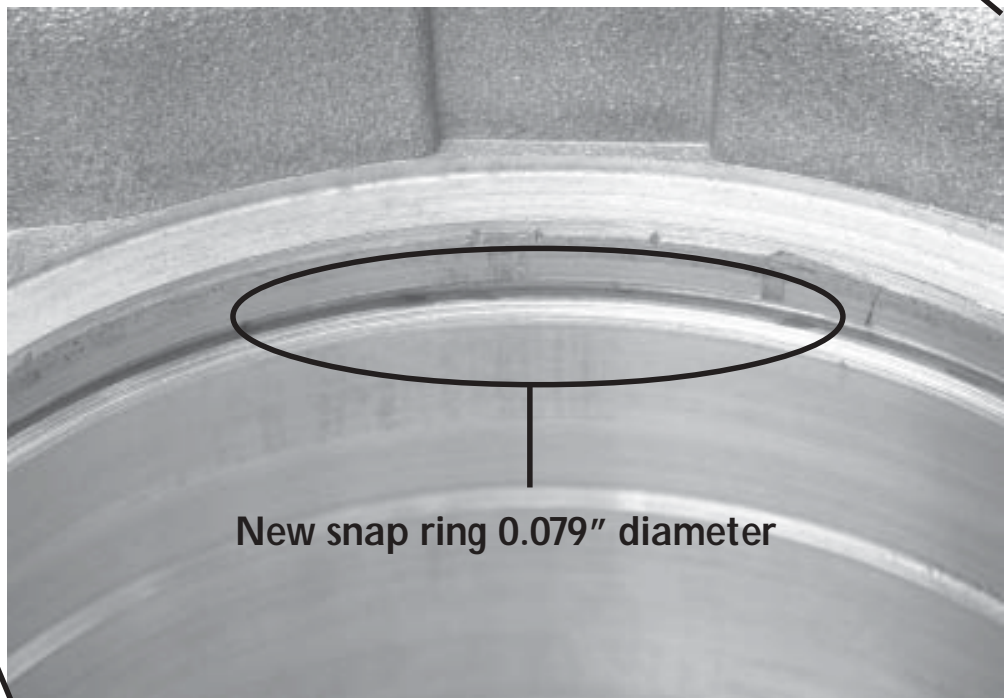
## *Case Damage from Servo Blowout*

A case change was made to increase durability of the Intermediate/Overdrive servo. The new case has a wide groove and must have the correct snap ring installed.

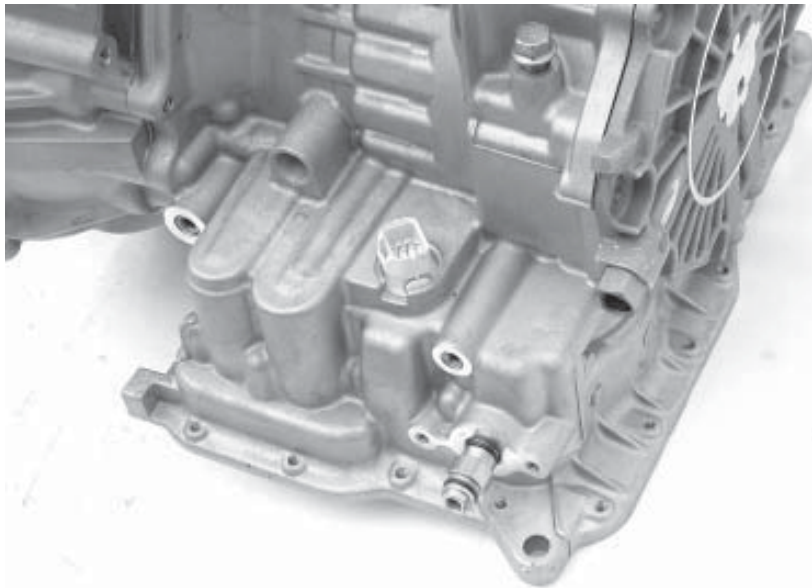
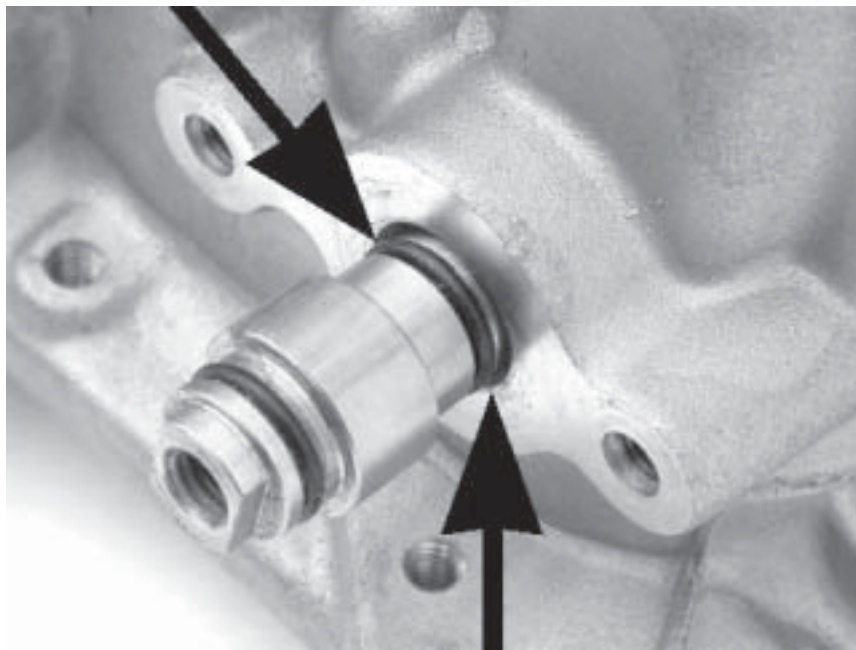
## *Transmission Manual Shaft Leak*

**Common Cause:** Manual shaft O-ring leaking, causing fluid to leak into the TRS. During early production a number of transaxles were assembled with a manual shaft O-ring that's diameter was too large. During installation these O-rings were cut or pinched causing them to leak.

**Repair:** Install new, smaller diameter O-ring-part # **XS4Z-7B498-AB**.

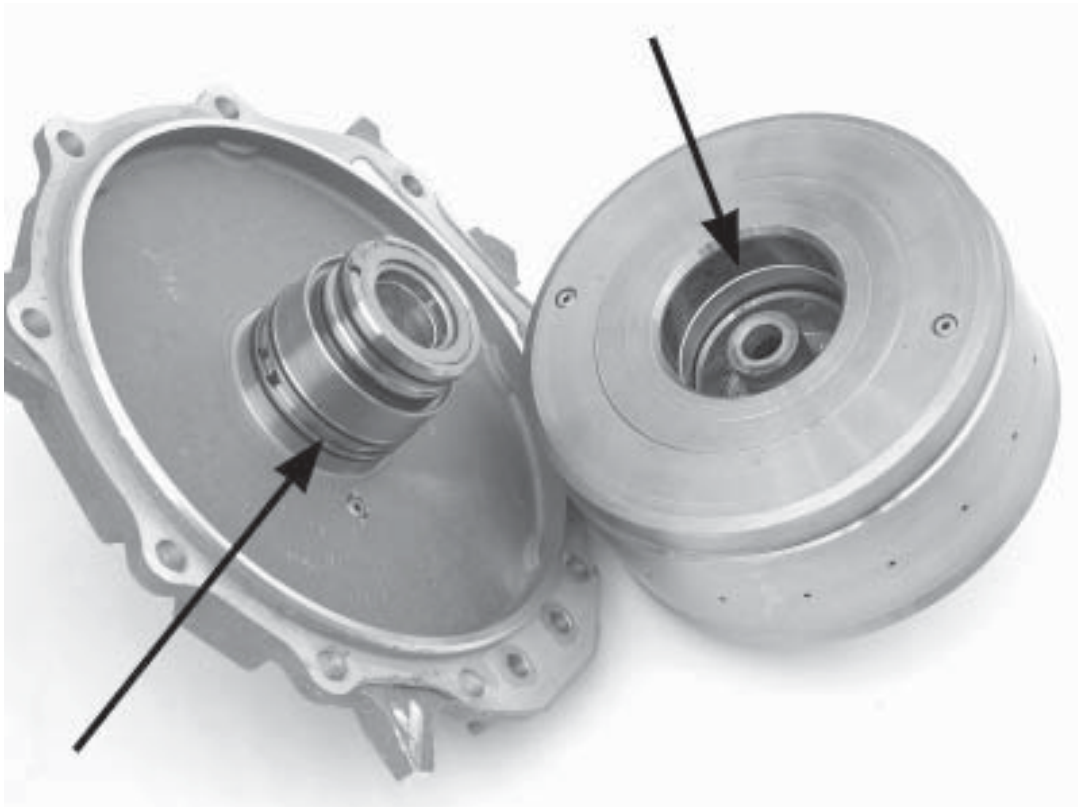
## *Delay or No Reverse*

**Concern:** Delayed or no reverse all other gears normal.

**Common Cause:** High pressure due to pressure regulator valve wear causing reverse clutch drum to side load on the rear support.

**Repair:** Replace drum, support assembly and valve body.

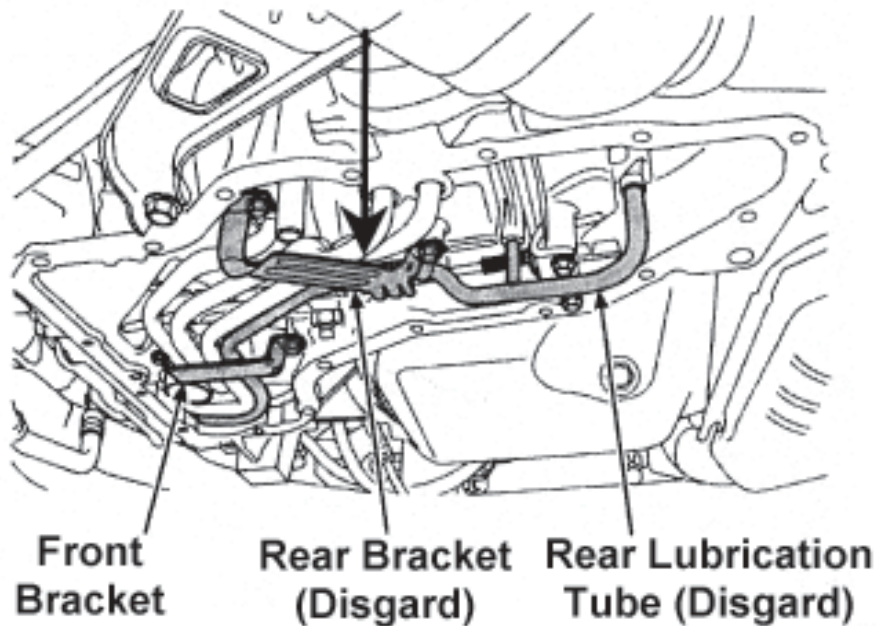
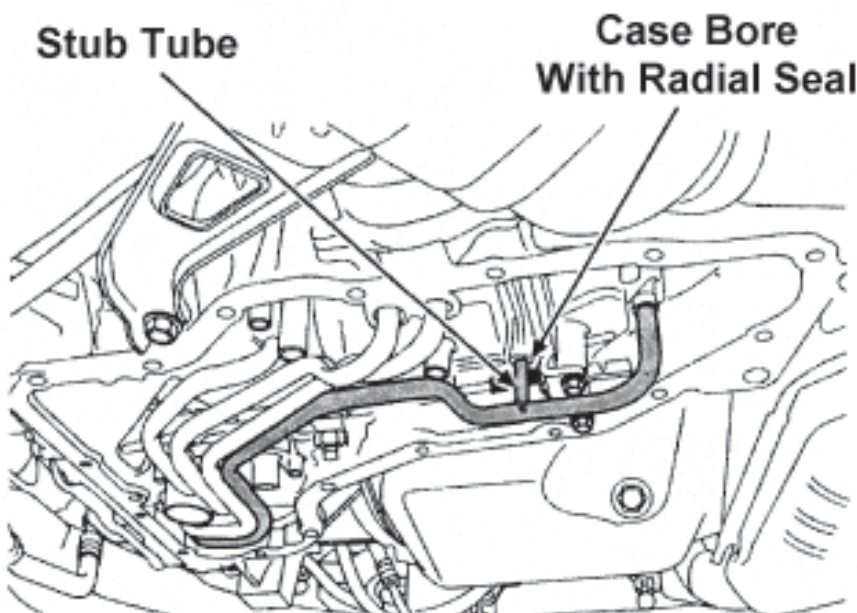
## Rear Lube Tube Cracking

**Cause:** A loose fit of the tube to the case assembly allowed the tube to vibrate and move, causing it to crack at the stub area.

**Repair:** Replace with redesigned tube and rear bracket. FORD part number 1F1Z-7G353-AA

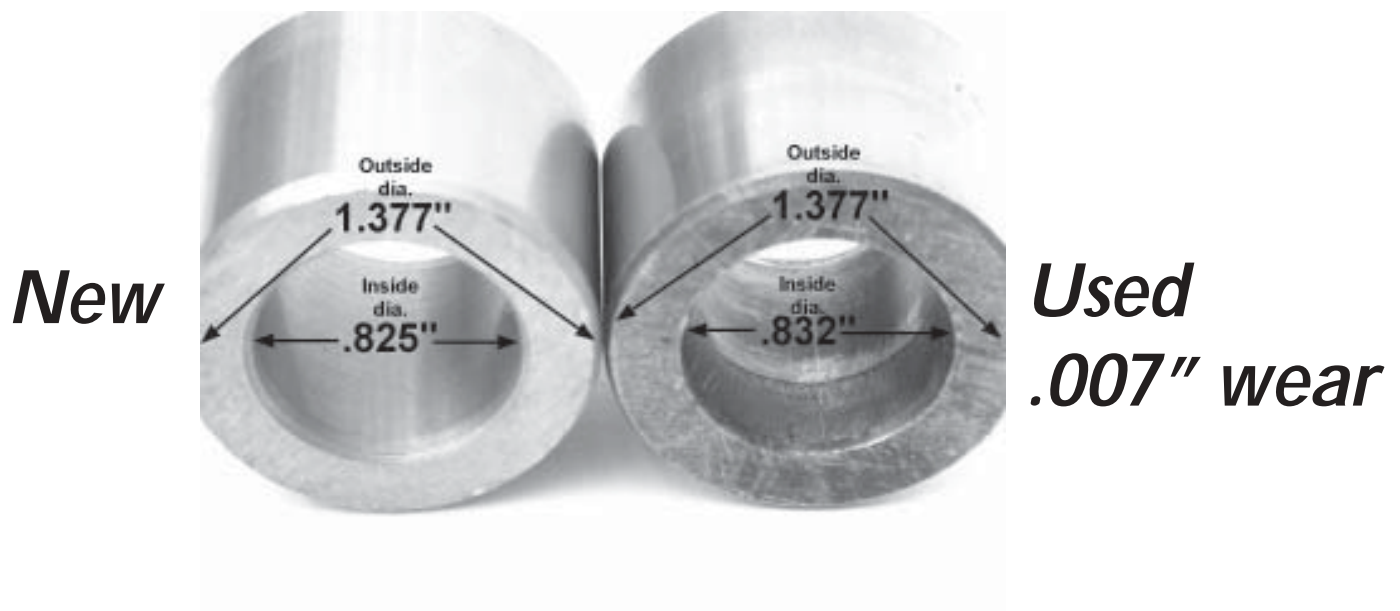
## 3.8L Torque Converter Pilot Bushing Wear

**Concern:** When a replacement transmission or engine is necessary make sure to visually check the torque converter pilot bushing in the crankshaft for excessive wear.

**Cause:** Pilot bushing in the crankshaft worn, allowing the torque converter to run off center.

**Repair:** Replace the bushing and check the run out.

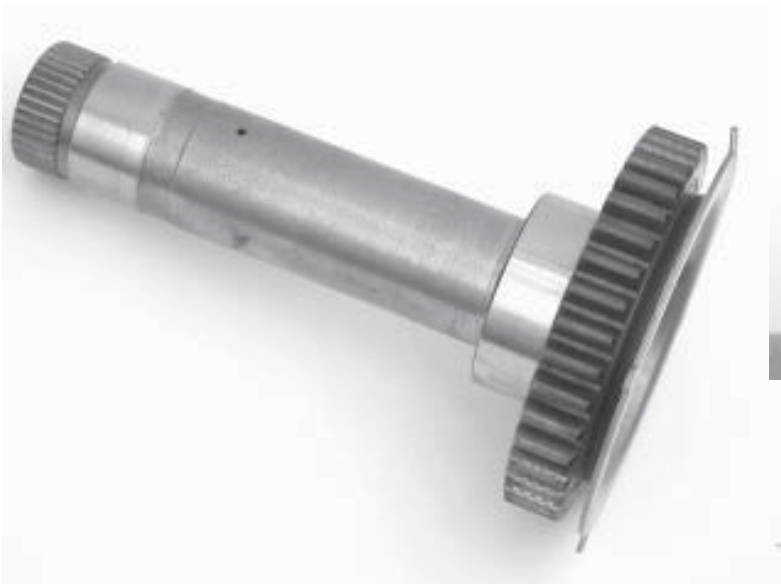
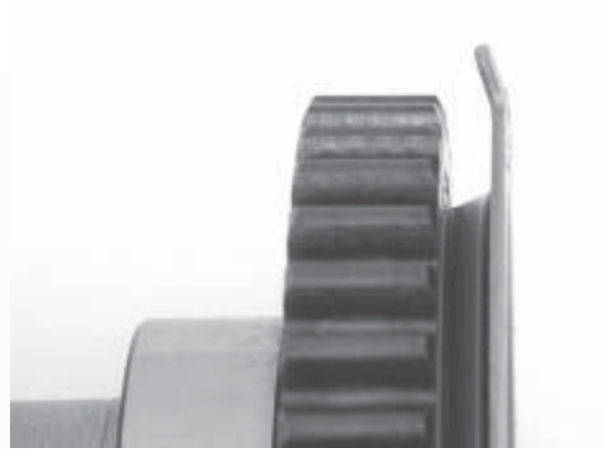
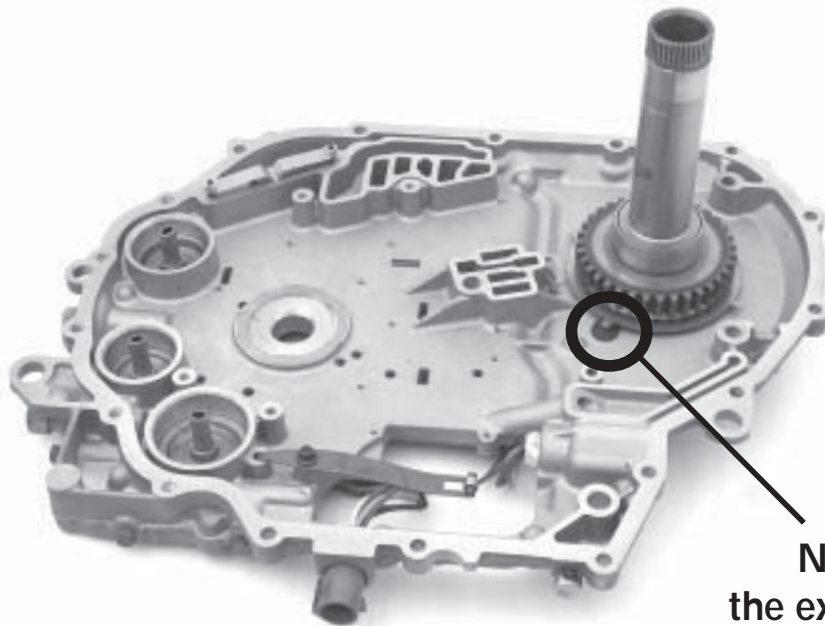
## TSS Exciter Wheel Bent

**Concern:** Damage to the exciter ring on the driven sprocket, (primarily on 1996-1997 model years).

**Common Cause:** The exciter ring may cause the PCM to control line pressure higher than normal.

**NOTE:** Measurement from the exciter ring to the tip of the sensor is .050"-.055".

**Repair:** Straighten or replace sprocket.

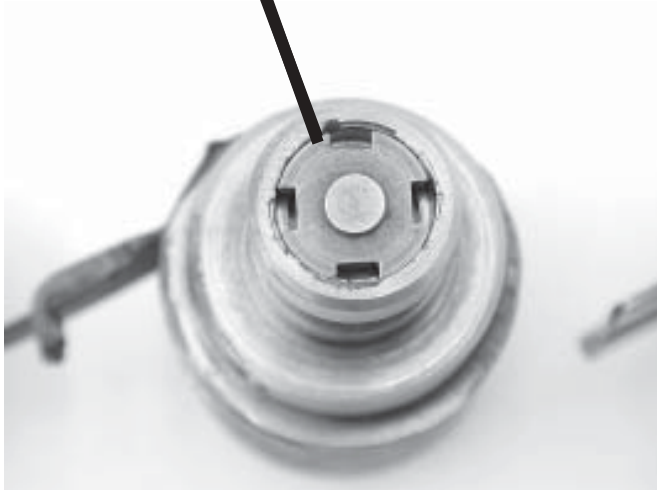
### Damaged TCC Solenoid

**Common Cause:** TCC solenoid (there were certain TCC solenoids that were poorly designed and the result was the tip blowing out and the brackets were cracking).

**Note:** *Make sure not to reuse lot numbers between 769 and 771, these solenoids are defective.*

Check the crimped area for cracks.

**Repair:** Replace solenoid.

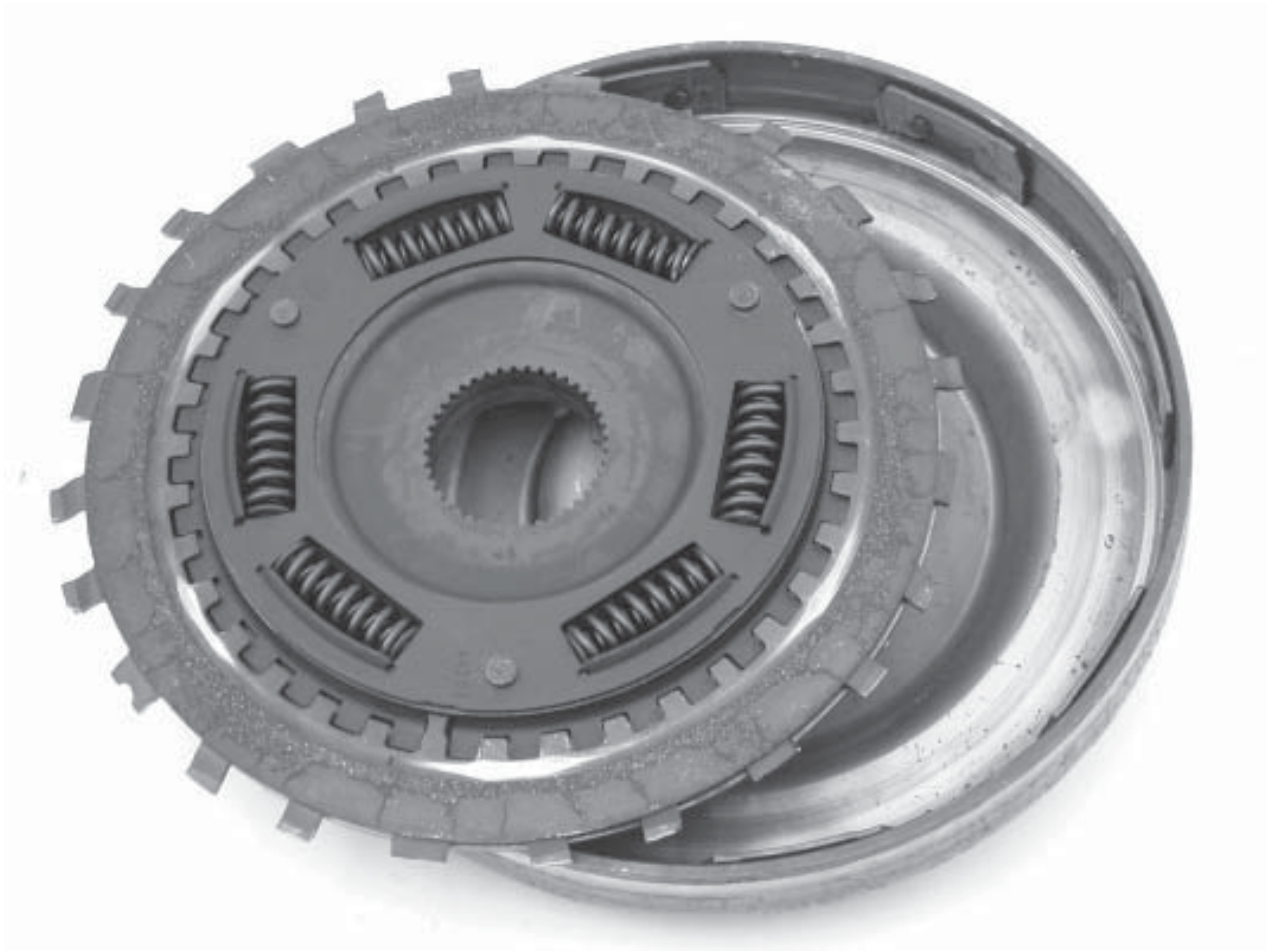
### *Torque Converter Clutch Failure*

**Common Cause:** Torque converter lining burnt or flaked off.

**Repair:** Replace converter.

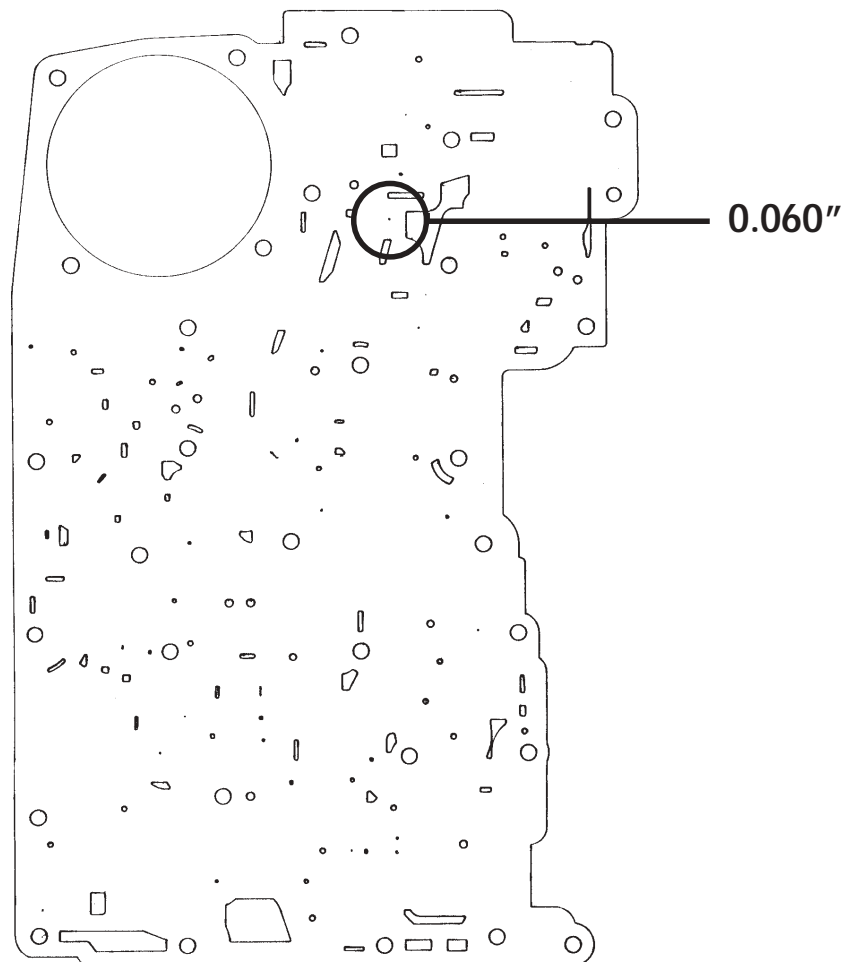
**Common Cause:** The separator plate may have the wrong size feed holes. The converter feed holes are normally between 0.032" and 0.048".

Modify the Separator plate to increase cooler flow. Cooler flow should be a minimum of 1 quart in 20 seconds. Make sure line pressure is within specification, high line pressures can cause low cooler flow.

**Repair:** Drill the converter feed hole in the separator plate to 0.060" for increased cooler flow.

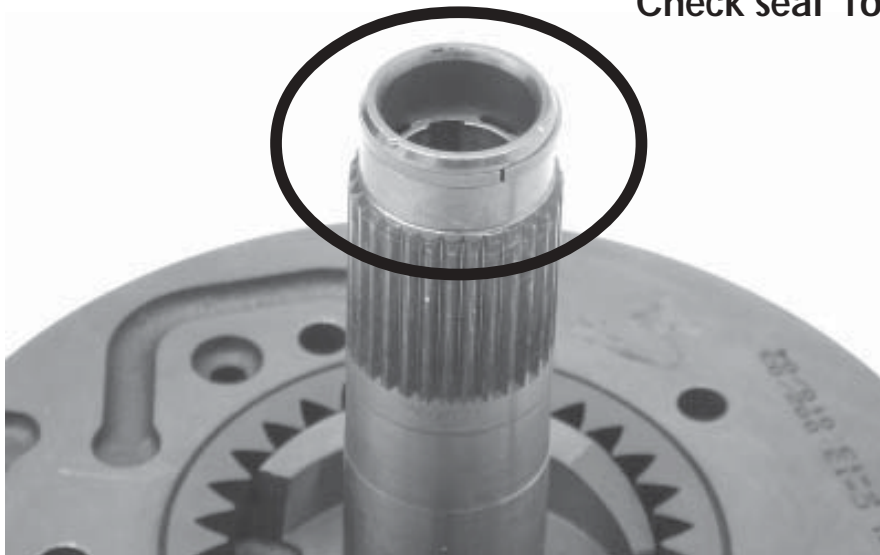
### ***Butt-cut Seal Damaged***

**Common Cause:** Seal broken or stator shaft worn or cracked.

Check seal for damage.

**Repair:** Replace seal and check stator support for shaft wear or cracking around the seal area. If crack is evident replace stator.

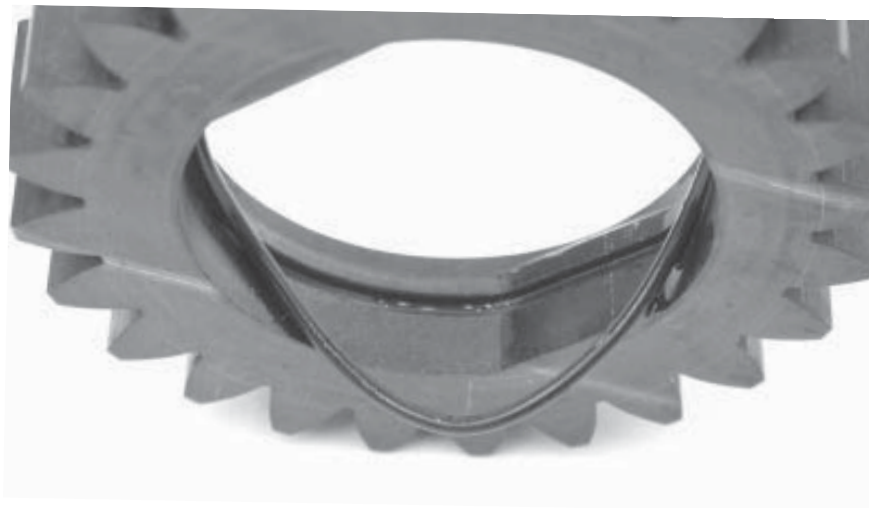
### ***Inner Pump Gear Seal Damaged***

**Common Cause:** Installing A4LD pump gears that don't have an O-ring, or correct pump gear inner O-ring damaged or missing. This will allow converter charge oil to leak into the converter bushing lube or drain back passage creating low converter charge.

**NOTE:** Must have gear with o-ring.

**Repair:** Install correct pump gears and O-ring. Inspect converter hub and lubricate prior to installation.

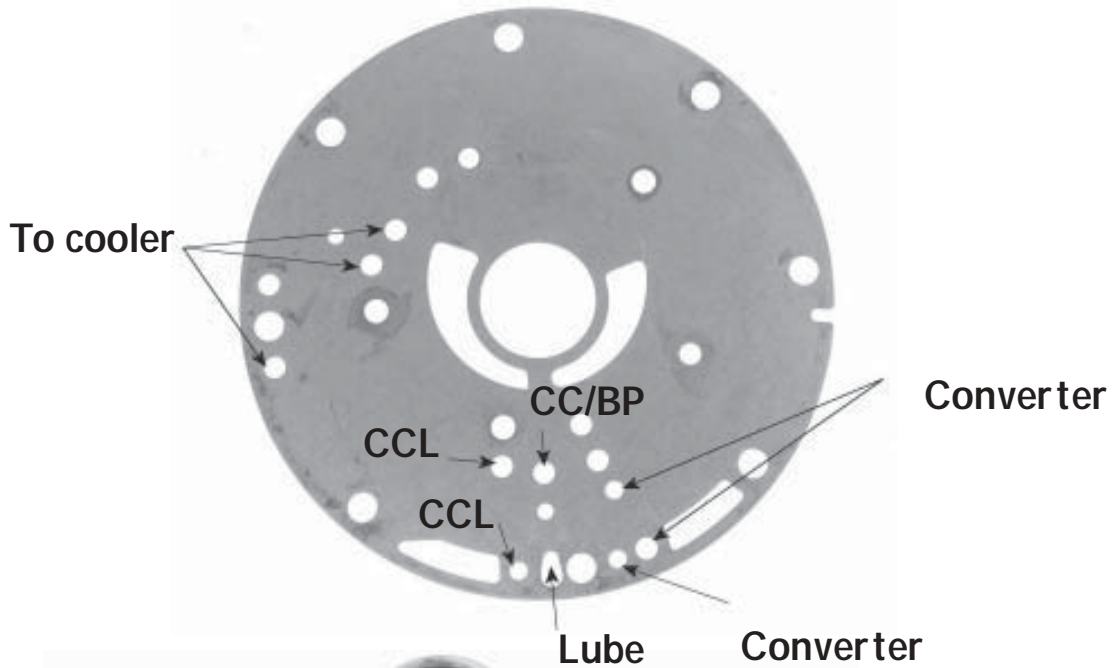
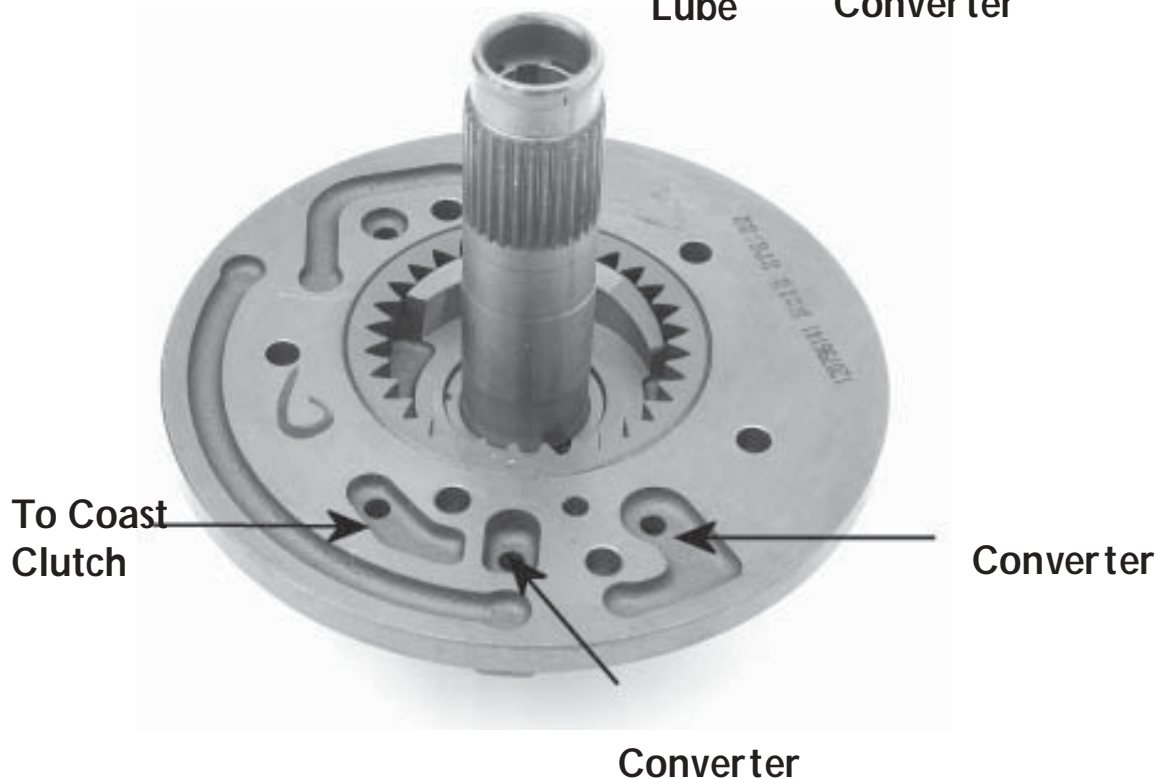
### Pump and Spacer Plate Damage

Always inspect Pump assembly for damage, note any wear marks or warping and replace if necessary.

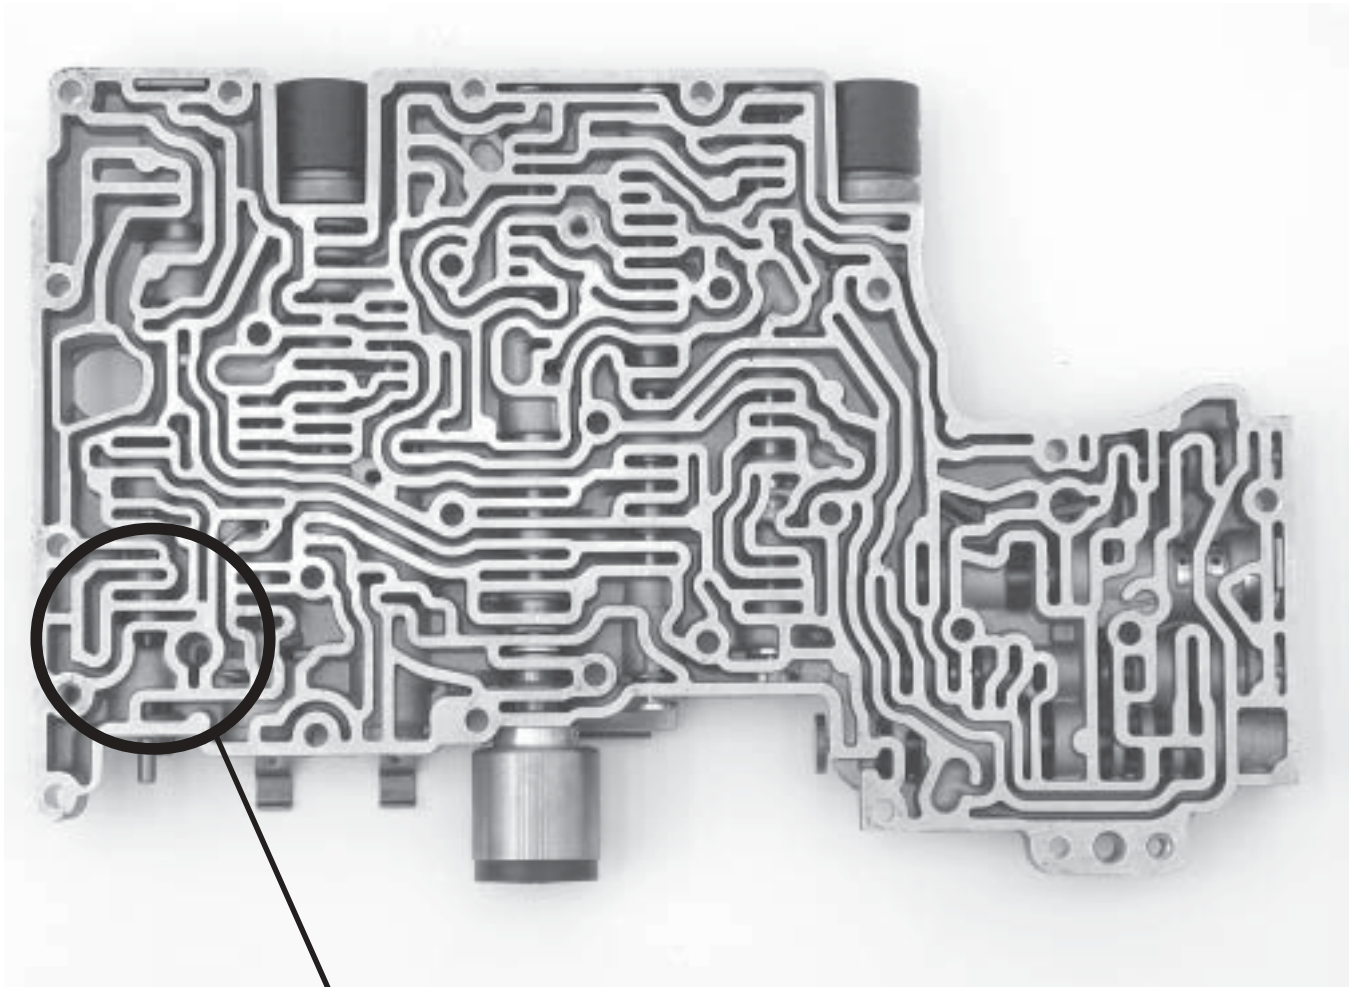
***Valve Body Damage***

**Common Cause:** Wear in the Valve Body.

**Always check valve body surface for warping**

**Repair:** Repair or Replace Valve Body.

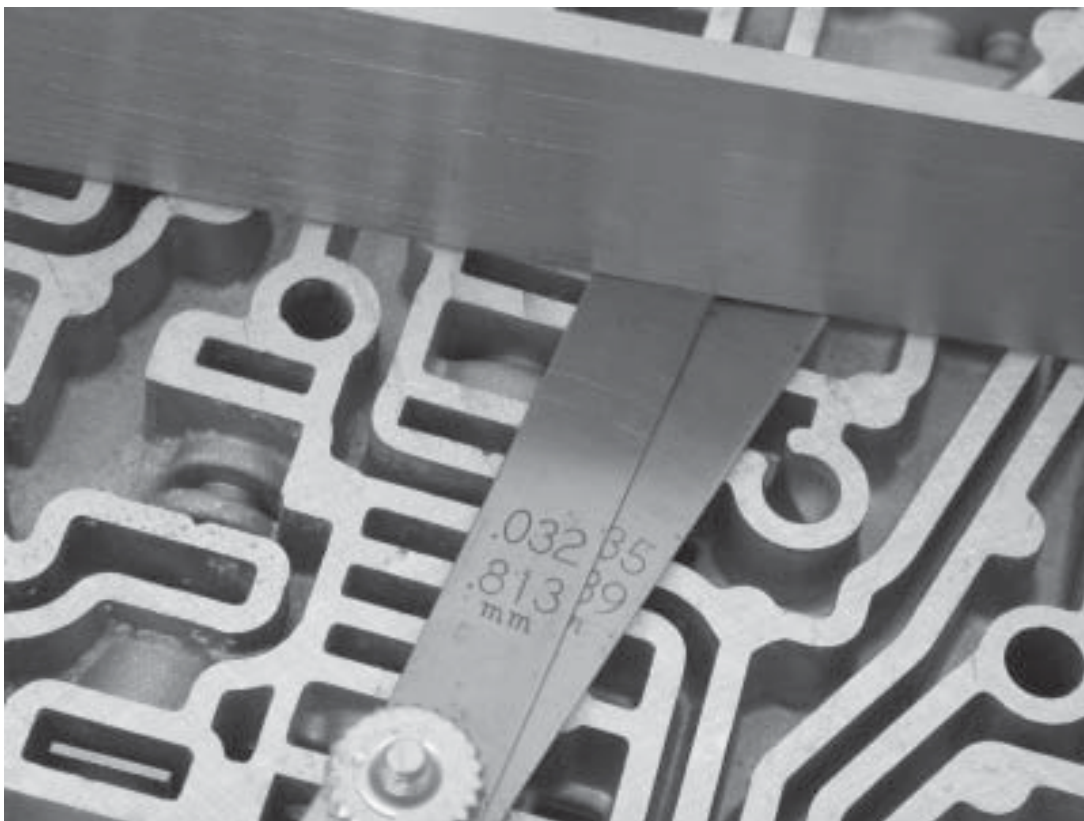
### **Valve Body Warping**

**Note:** Measurements should not exceed more than .005" clearance.

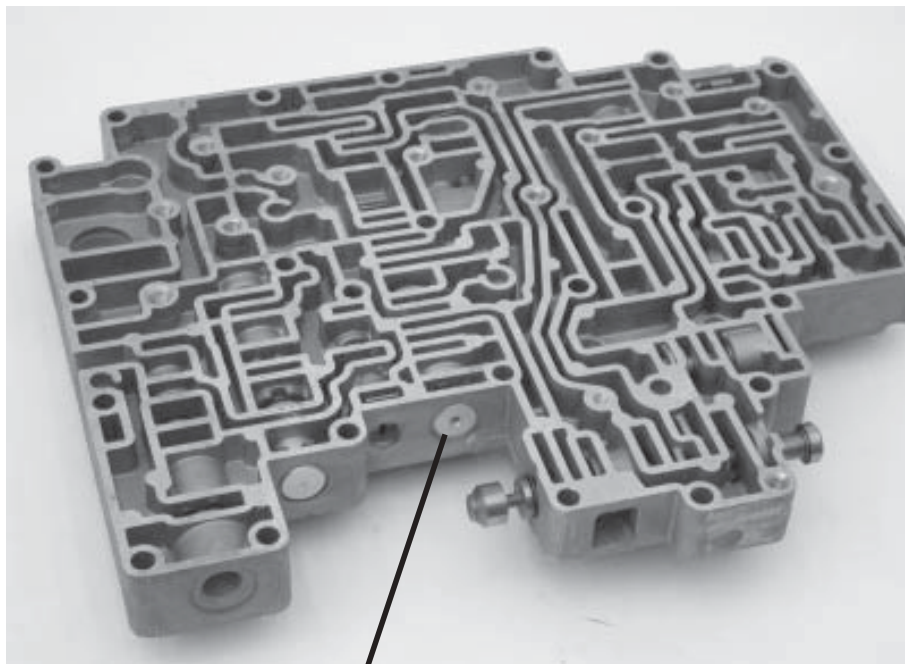
2-3 shift valve end plug

**Concern:** During a 3/4 shift or just accelerating in 4th the transmission neutralizes. No codes present and the correct commands are being sent to the transmission.

**Common Cause:** 2/3 shift valve end plug leaking. This leak causes the direct clutch to be cut off due to the amount of solenoid oil pressure required to keep both the 3/4 shift valve and the 2/3 shift valve in the stroked position. Because the 2/3 shift valve has only one area for solenoid pressure to pin the valve versus two for the 3/4 shift valve it is more likely to be susceptible to the leak.

**Testing & Repair:** Install a pressure gauge on the direct clutch tap. When the transmission neutralizes if the gauge shows little or no pressure, then remove the 2/3 shift valve end plug and run a tubing cutter around the outside diameter to seal the leak.

**NOTE:** While performing this repair also check the 2/3 shift and solenoid pressure regulator valves and bores for wear.

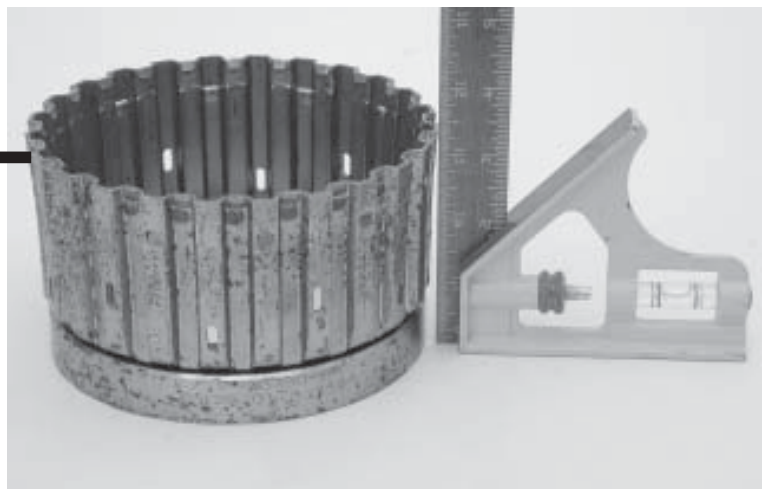
**Common Cause:** This condition is often due to low line rise. The computer command for line rise isn't adequate for the conditions.

Notice the drum flared at the top.

**Repair:** Ford has issued an update computer calibration. Use the transmission tag number and calibration number to determine whether the truck requires this update.

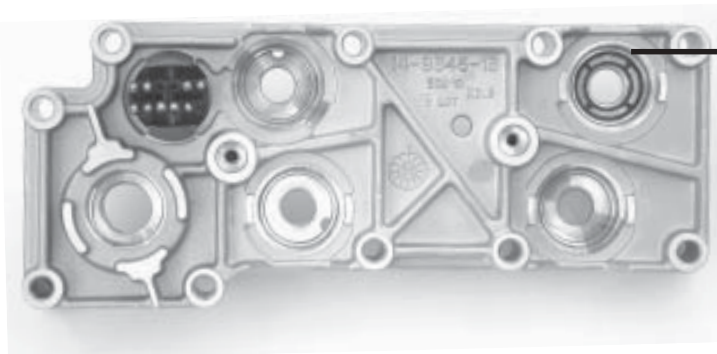
PWM screen

- The second design PWM solenoid body has a GREEN top cover and a screen for the PWM circuit. However, this solenoid body caused a 2-3 and 3-4 shift flare with marginal fluid capacity at the PWM solenoid. The PWM solenoid and PCM calibration had to be updated.  
**Note: This change resulted in the third design replacement solenoid body! (Do not use the second design solenoid body)**

- The third design replacement solenoid body has an Orange top cover.  
**Note: This solenoid body has a screen!**

This screen is not serviceable. When replacements are necessary it will be necessary to replace the solenoid body assembly.

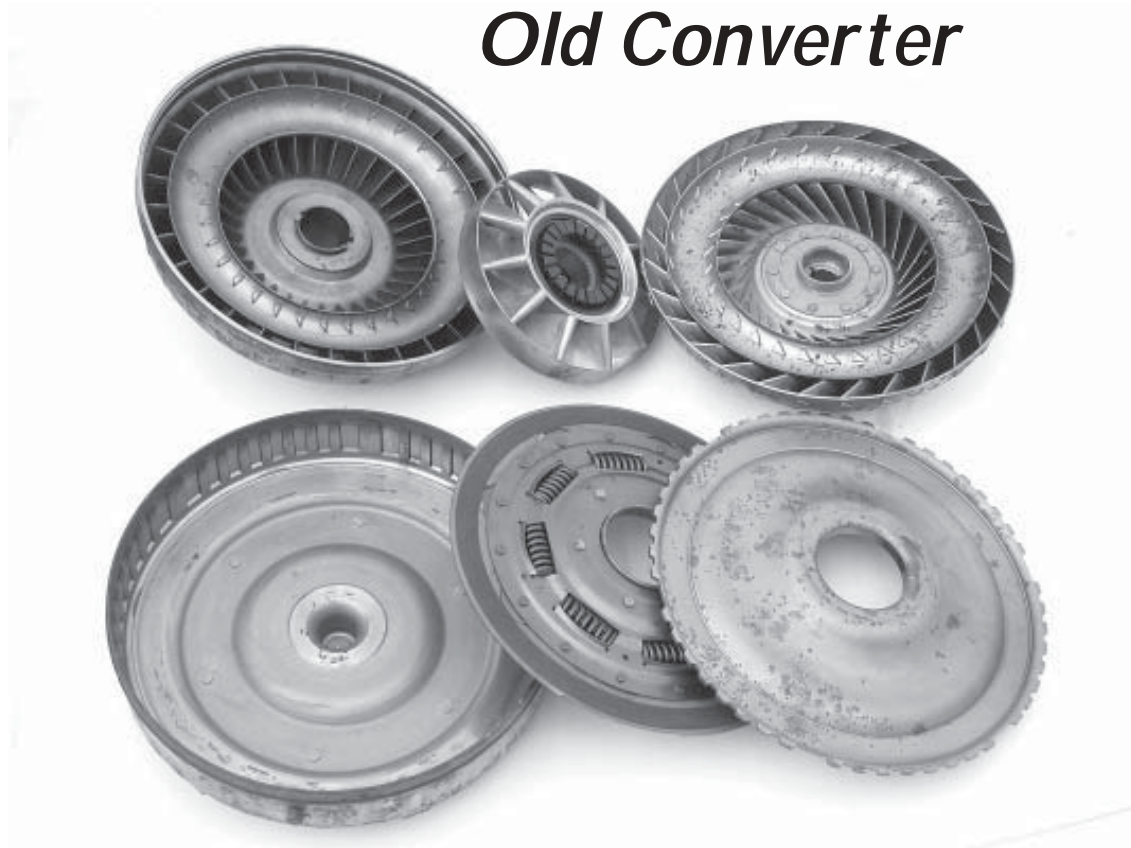
### *Old Converter*

**Common Cause:** The impact between the outer lugs at the converter piston and the cover. To confirm this problem you can command the torque converter on from the computer or test it at the transmission.

1. Ground PIN #54 at the computer to fully apply the converter clutch.
2. Cycle the converter ON and OFF a few times by applying and removing the ground from pin #54.
3. If the noise goes away when the converter is applied, replace the torque converter.

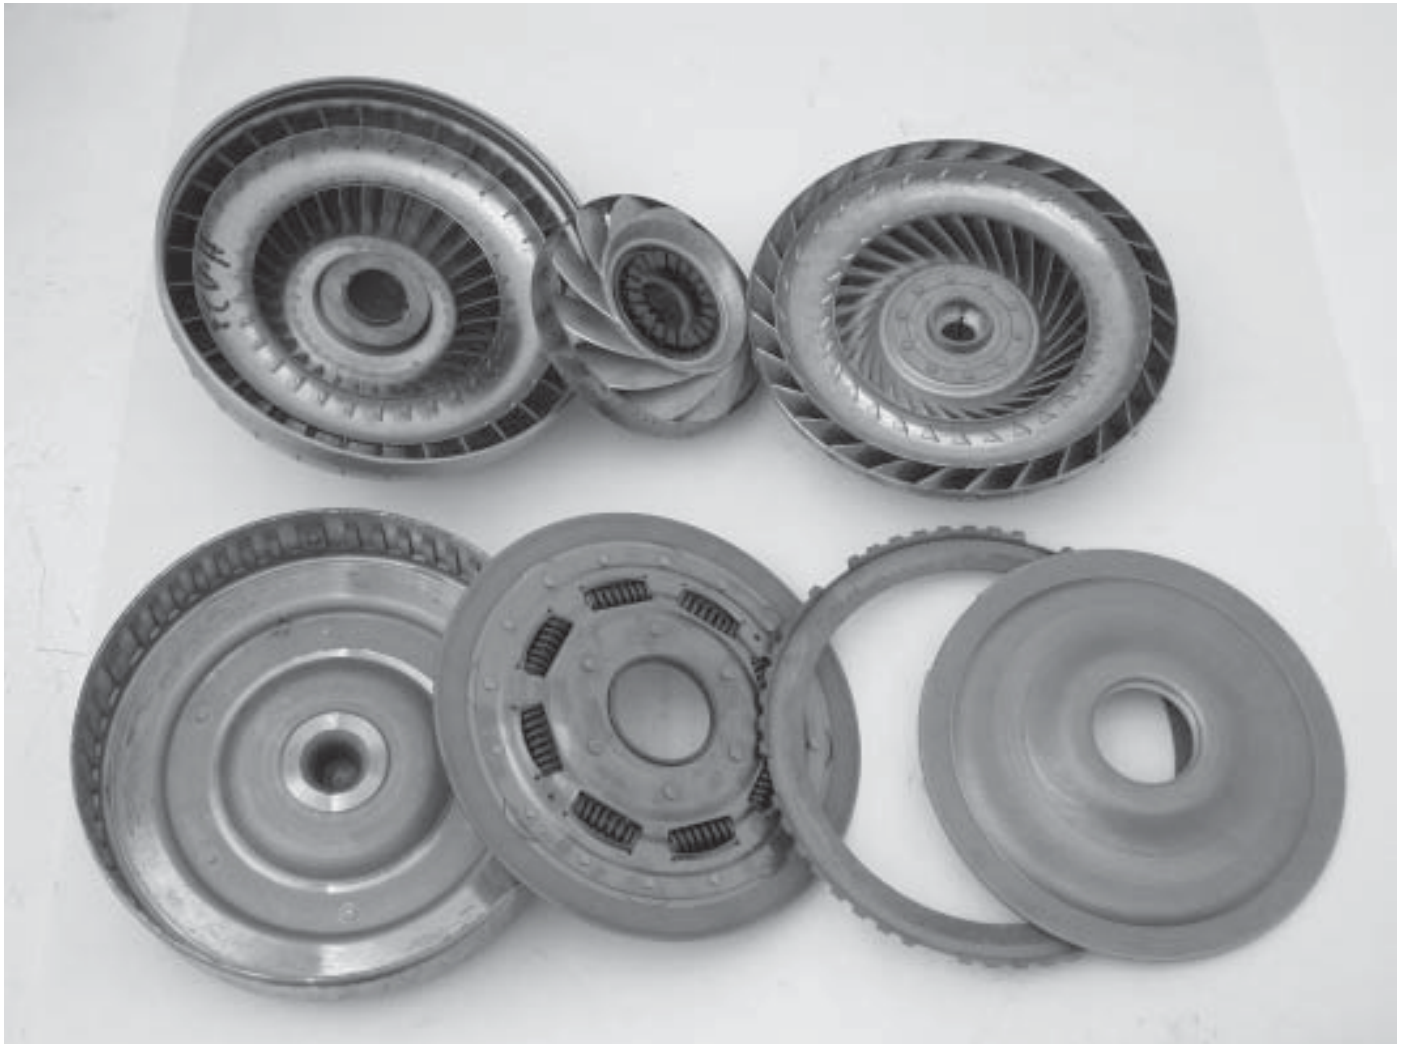
### *New Converter*

**NOTE:** Replacement converter comes with a two piece apply piston

**Repair:** Replace Torque Converter with Part# XL3Z-7902-DARM
