BW 4484 H2 Applications

Locked in 4WD, Binds on Turns

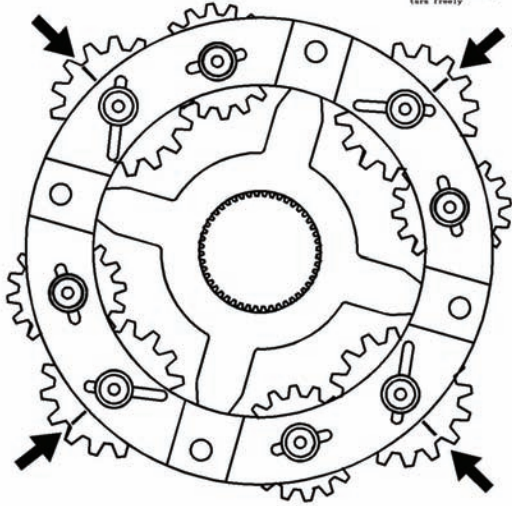
Maybe lines, dots or triangle that will have to face out
