he Ford E4OD-4R100 has become the breadwinner transmission in a lot of shops. Although this workhorse has gone through a few changes over the years, the general diagnostic and repair processes have remained virtually the same.

An issue that's been showing up too often is when the transmission skips  $2^{nd}$  gear; it shifts 1-3-4. This may occur while the transmission is in service or show up after a major repair.

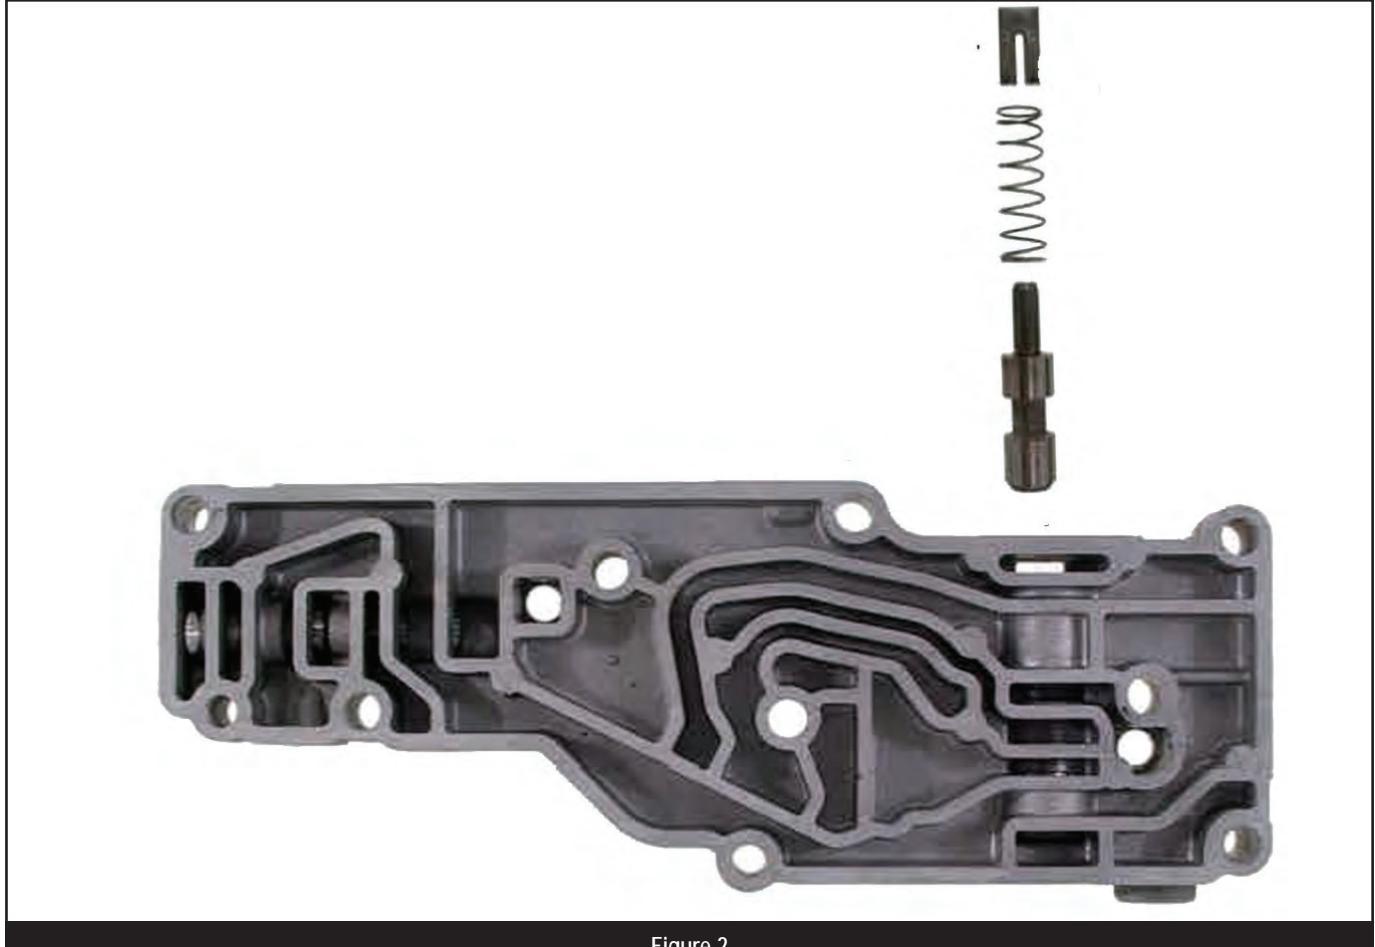
Figure 2

• 1-2 transition valve — stuck in the shifted position, holding the spring compressed (figure 2). If the transmission has a manual
