Nothing But AIR!: VVV 090G

by Jarad Warren members.atra.com

2005 Volkswagen Jetta with a 09G transmission came in with a complaint of shifting 1-2-3 then neutral when hot. When cold the car shifted okay and there were no codes.

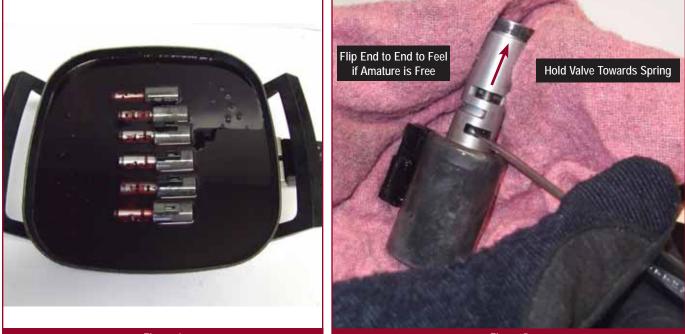
Figure 4

after the repair. Figure 3 shows the solenoid ID and locations. Use an old hot plate to heat a pan of ATF to 200°F and drop the solenoid in (figure 4). Heating the solenoid lets you confirm that the solenoid sticks when hot.

CAUTION: Be careful handling the solenoids when they're hot.

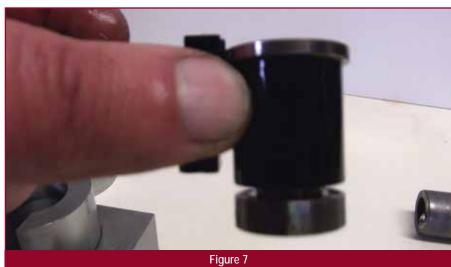
There are many different methods and tools available to take the solenoids apart and crimped back together. Figure 6 shows the solenoid taken apart and the parts labeled. Figure 7 shows the armature stuck in the N282 solenoid bushing. This confirms the complaint.

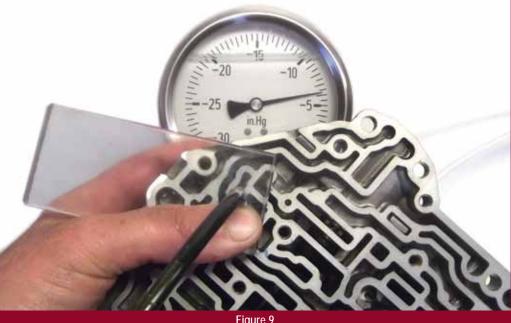
Figure 9

To vacuum test this valve (figure 9), place small amount of transmission assembly lube on the test port and cover. Notice the low vacuum reading: this bore needs to be addressed. I prefer the vacuum test because you can put a number with the test results and compare it to new, but use what

sales@etereman.com Copyright ETE REMAN 2013 - GEARS Magazine you're comfortable with. The most important thing is to look for wear. It's a good idea to start a test log for passing and failing valve body bores.

If the valve and its bore failed one or more of the tests, contact your parts supplier for the repair.
