2004 TECHNICAL SEMINAR

Automatic Transmission Rebuilders Association

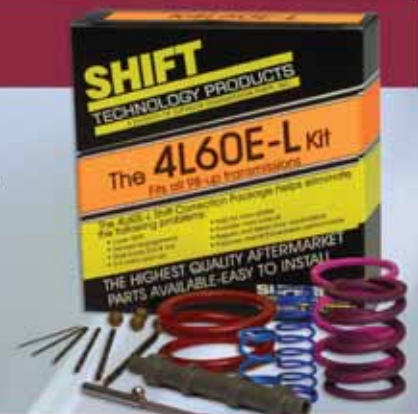
The 4L60E-Late Shift Correction Package 1998 & up (K4L60E-L)

The 4L60E-L Kit helps to eliminate the following problems: ✓ Code 1870 ✓ Delayed engagements ✓ Slide bump 2nd & 3rd ✓ 3-4 clutch burn-up ✓ Help for worn plates ✓ Provides more lube oil ✓ Regular and Heavy duty applications ✓ Improves overall transmission performance

- Includes PWM PowerValve to correct code 1870 problems and still maintain normal computer strategy of the converter.
- Includes oversized checkballs to give new life to the original worn separator plate.

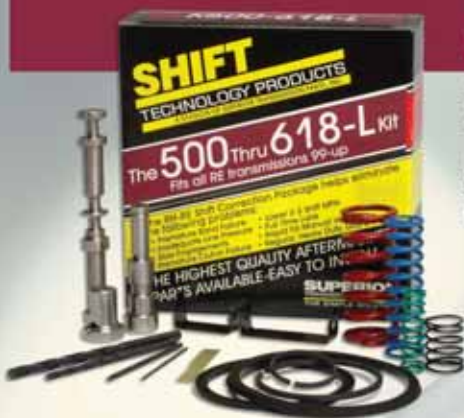
The Chrysler 42/46/47-RE Late Shift Correction Package 1999 & up (K500-618-L)

The Chrysler 42/46/47-RE Late Shift Correction Package helps eliminate the following problems: ✓ Premature band failure ✓ Inadequate line pressure ✓ Slow engagements ✓ Premature clutch failure ✓ Lower 2-3 shift RPM ✓ Full time lube ✓ Rapid fill manual valve ✓ Regular, Heavy Duty, Gas & Diesel

- The governor control valve limits excess governor pressure caused by increased mainline operating pressure needed for Heavy Duty use.
- Allows building the unit for extreme heavy duty applications without fear of getting governor sensor code 1763
- Works on any earlier RE unit, but most beneficial for 1999 & up unit with the latest computer strategy.

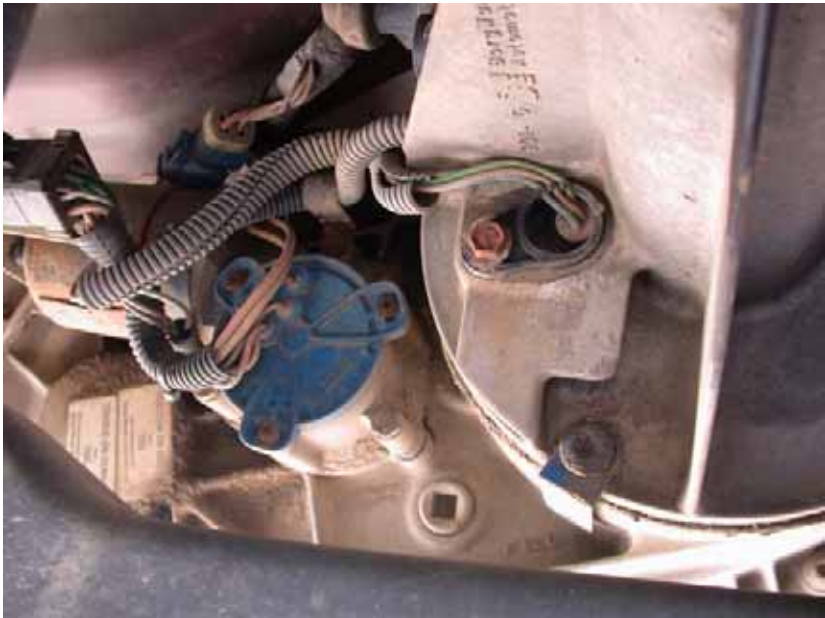
Old Number
F75Z-7G360-AA

Install a YL1Z-7G360-AA shift motor on vehicles built before 12/99. The YL1Z-7G360-AA shift motor with a grey contact plate cover replaces the prior design F75Z-7G360-AA motor with a blue contact plate cover. Grey-cover shift motors contain improved sense plate material and shift motor terminal upgrades. For vehicles already equipped with the latest style shift motor, refer to the following service procedure for details.

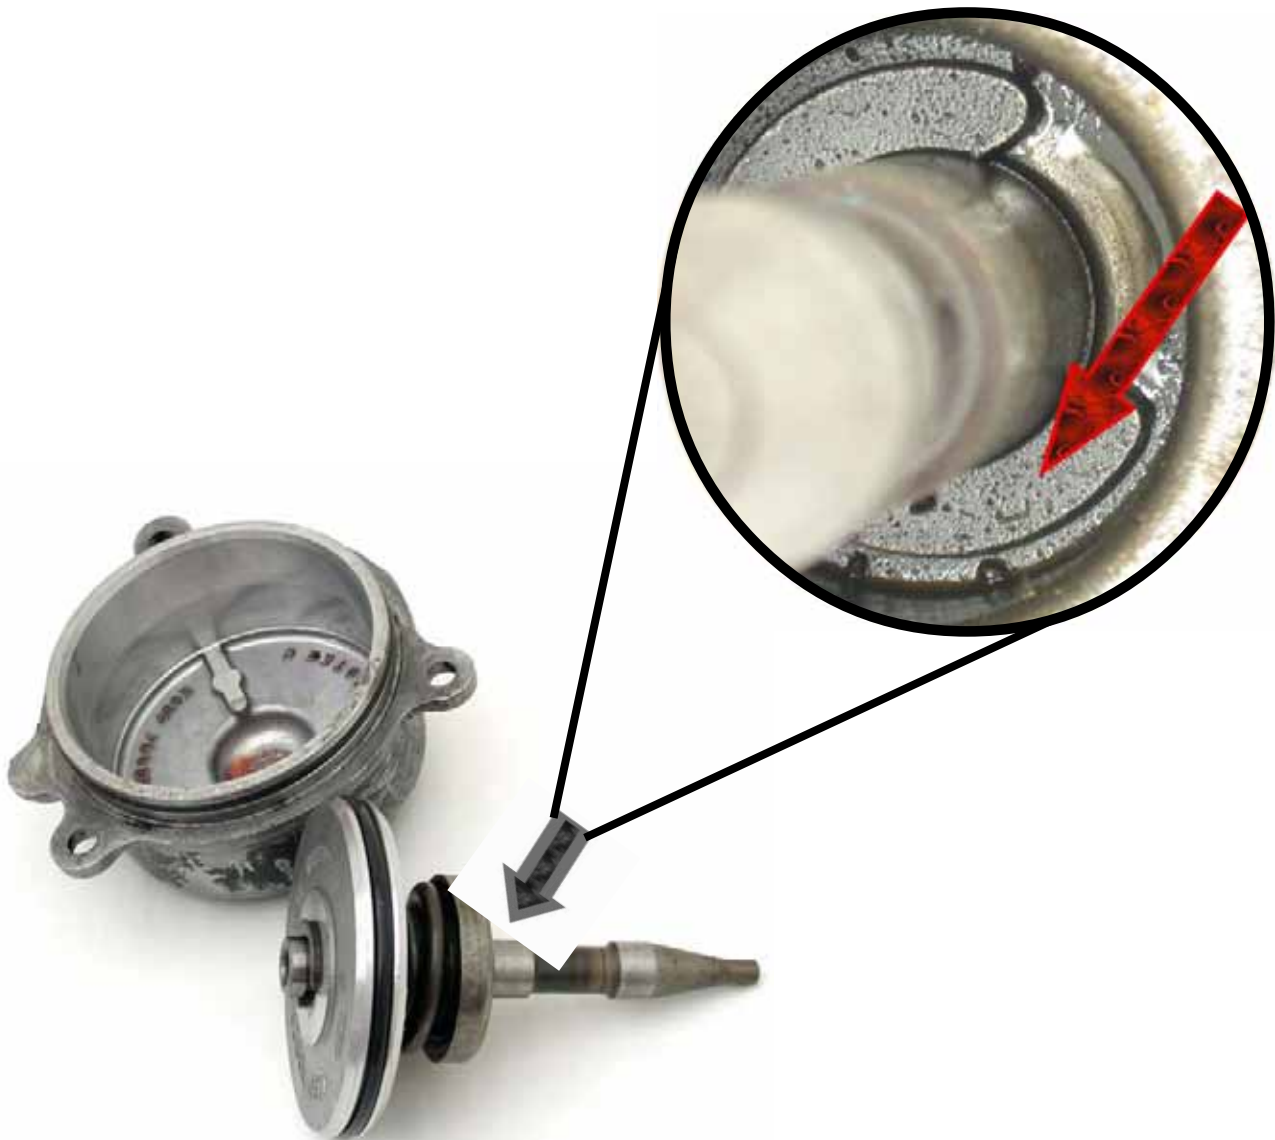
AX4S

No Movement

A no movement condition can be caused by the front clip breaking in the Low/Intermediate servo assembly.

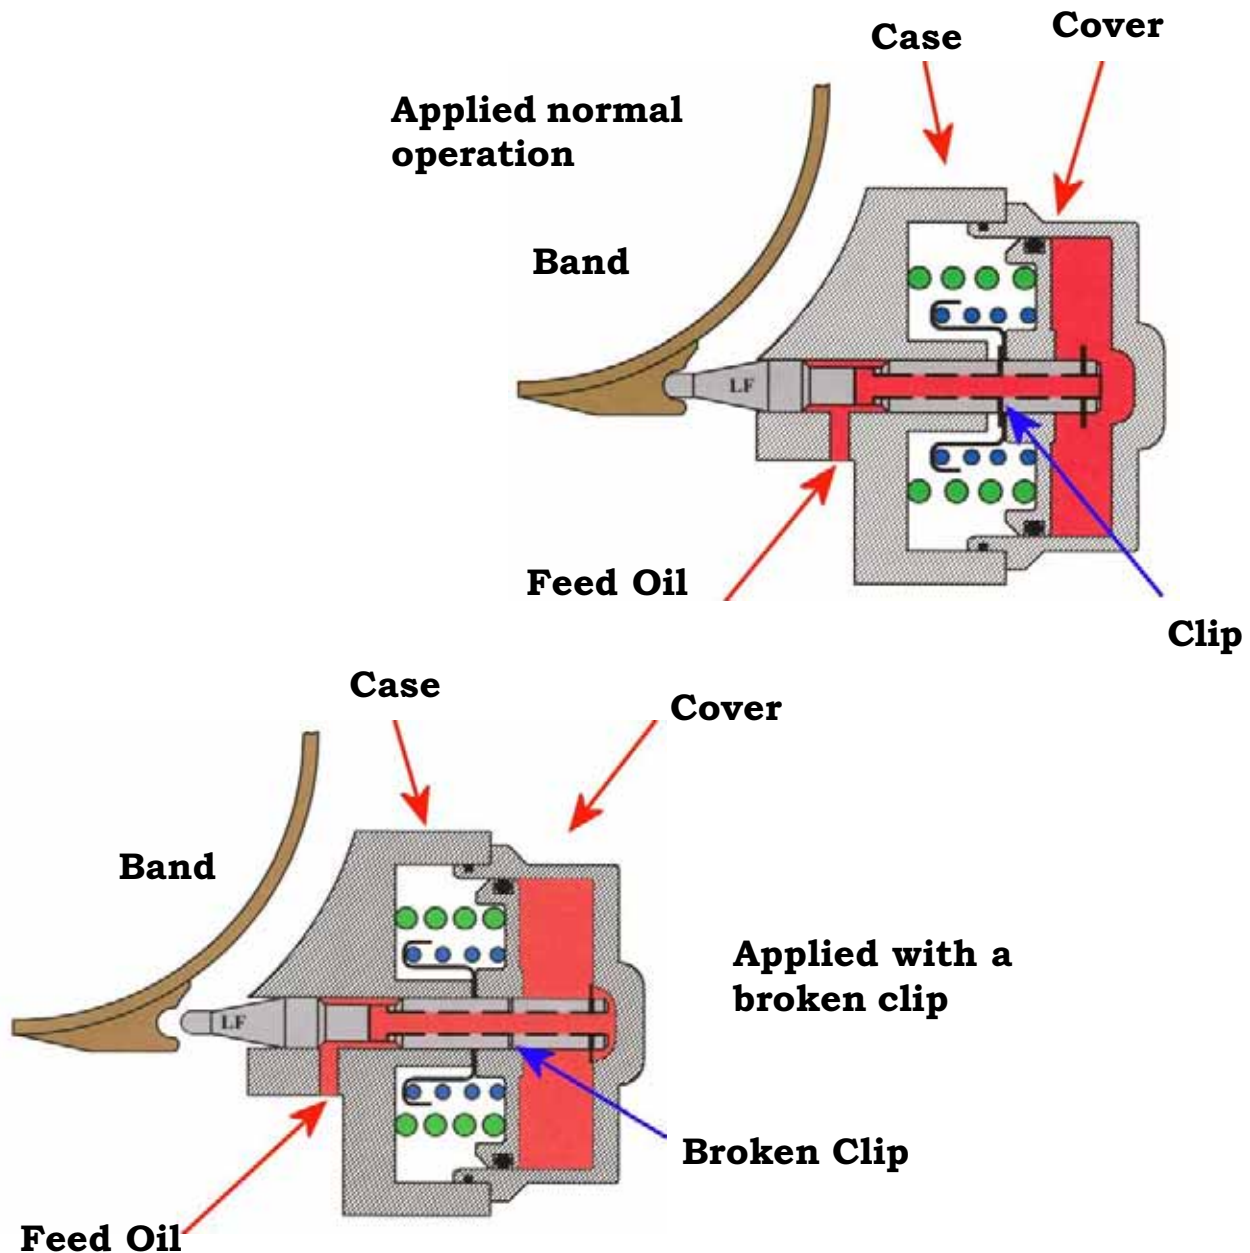
Oil enters the servo through the case and is directed to the top of the servo piston. If the clip is broken the piston will bottom out and the servo apply rod will be stationary and not apply the band.

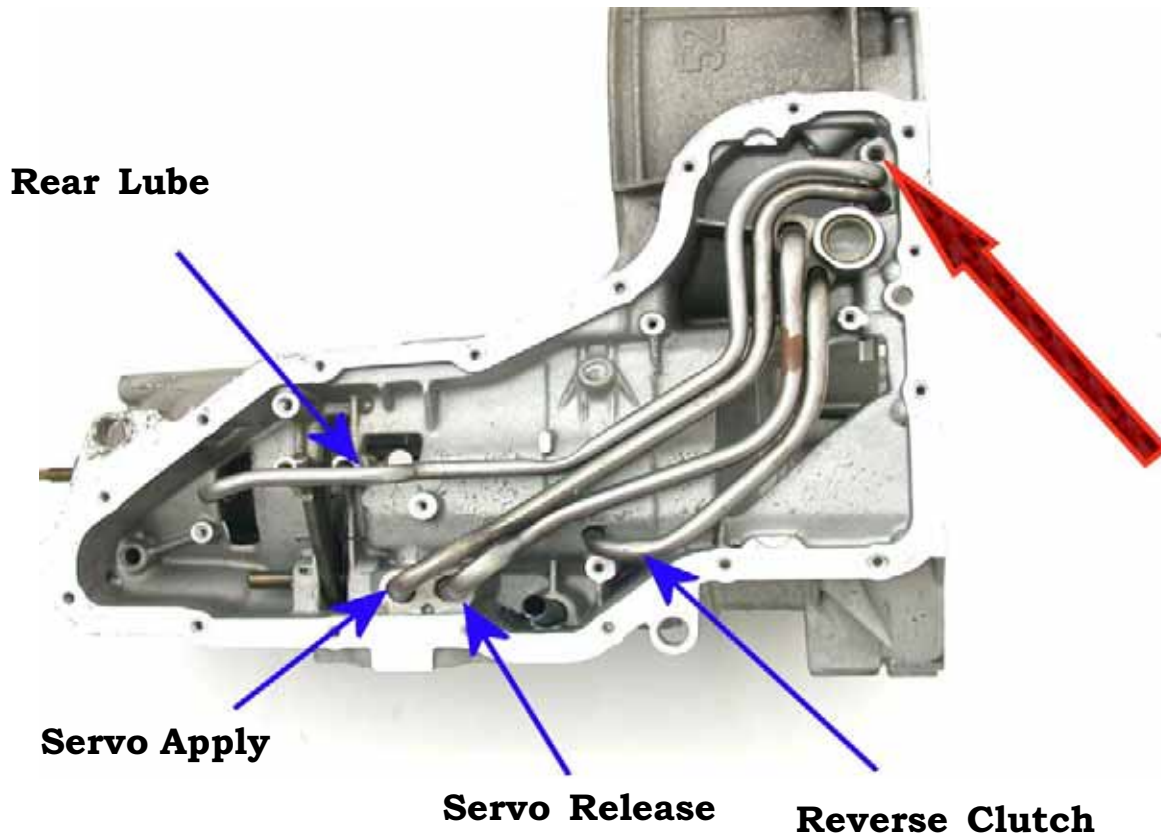
No Rear Lube Tube

All 1999 and newer AX4S transmissions have only four tubes in the bottom of the transmission. A new tube now incorporates the differential speedometer lube transfer tube that was deleted from production.

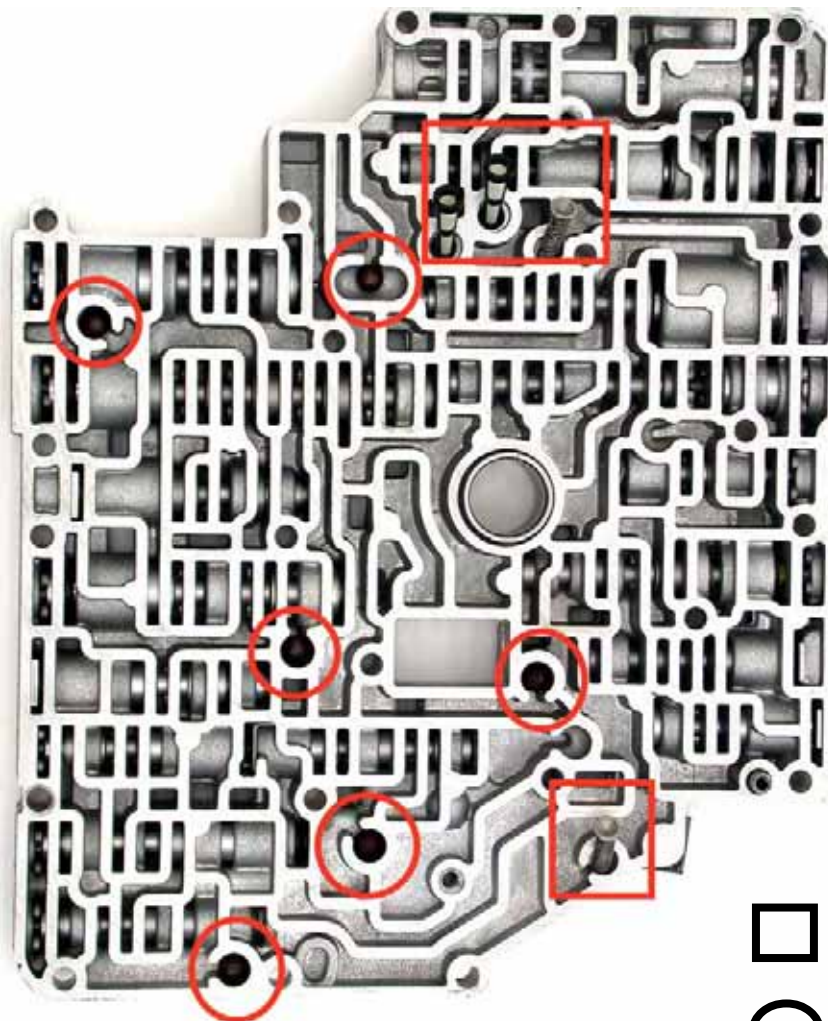
1996-1998 Valve Body Assembly

From 1996-1998 all AX4S valve bodies are interchangeable. These valve bodies have six Checkballs and two relief valves.

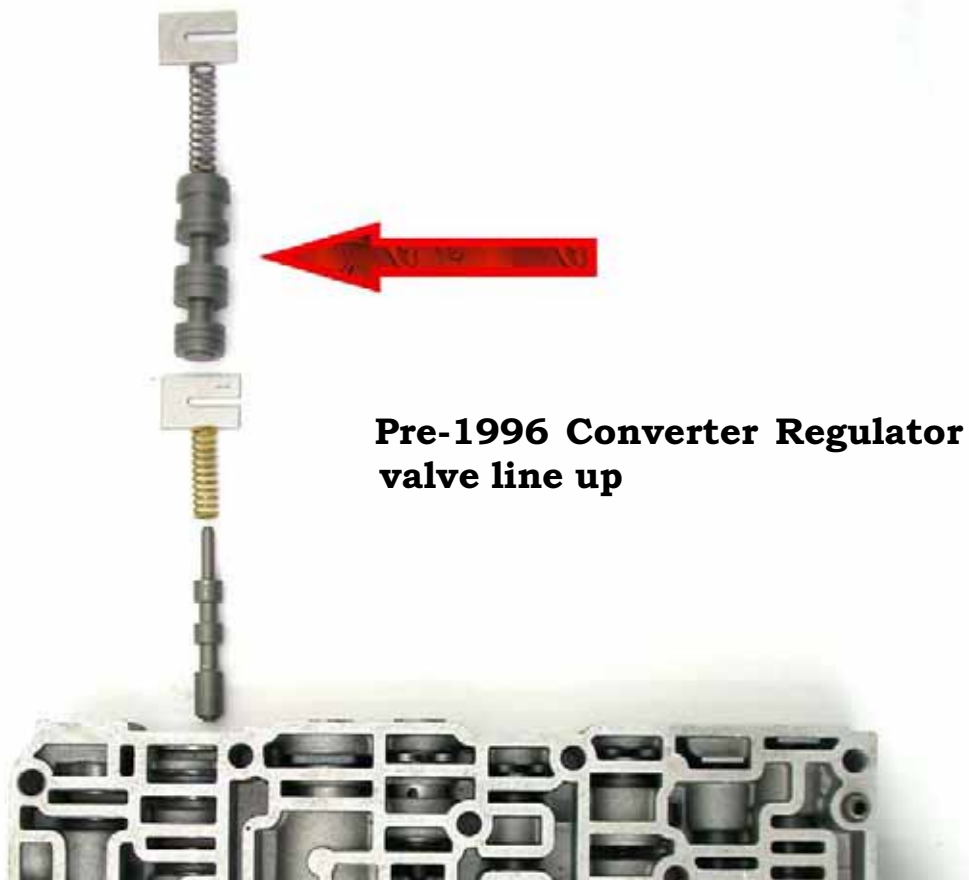
Pre-1996 Converter Regulator Valve Assembly

The Pre-1996 Converter regulator valve has four lands and is not interchangeable with later valve bodies.

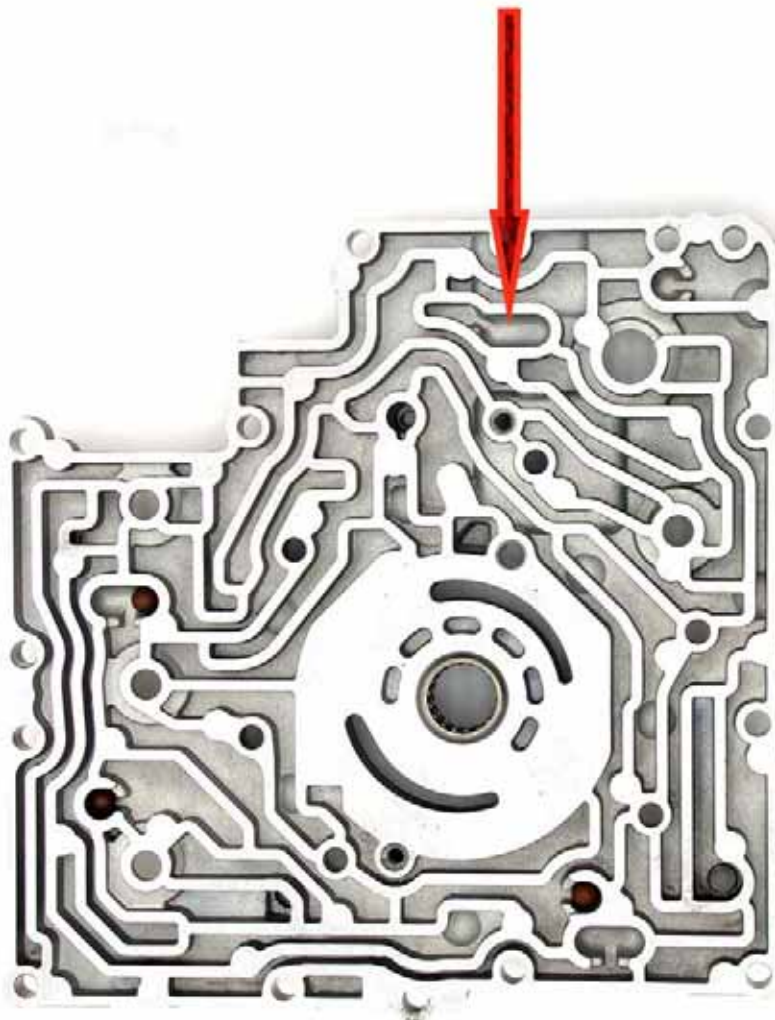
1999 -On Pump Body Assembly

1999 - On AX4S pump bodies do not have a CB "5" checkball. One easy way to determine if your plate and valve body are correct is the number of holes over the CB "5" checkball bathtub. One hole means no check ball, two holes means a check ball is required.

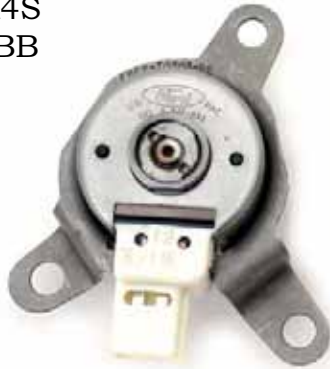
New part # AX4S
F8DZ-7G383-BB

The AX4S and AX4N EPC solenoids are interchangeable, they have the same resistance, and connector. The only difference is the bracket, which is removable and can be swapped if necessary. The cost is about \$10 less then the AX4N solenoid.

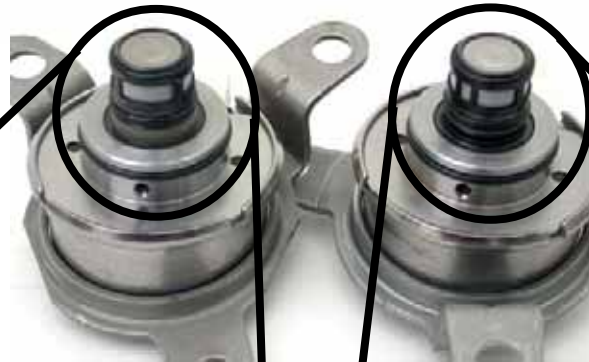
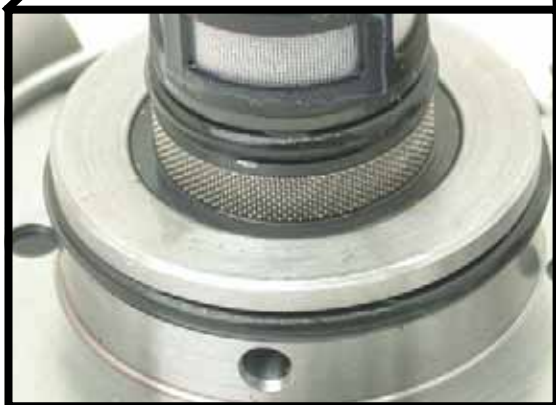
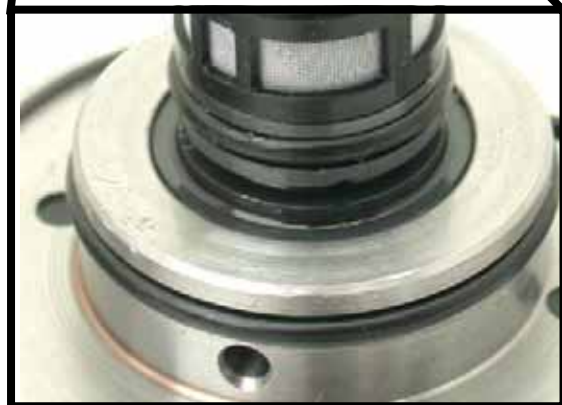
New part # AX4N
F8DZ-7G383-AB

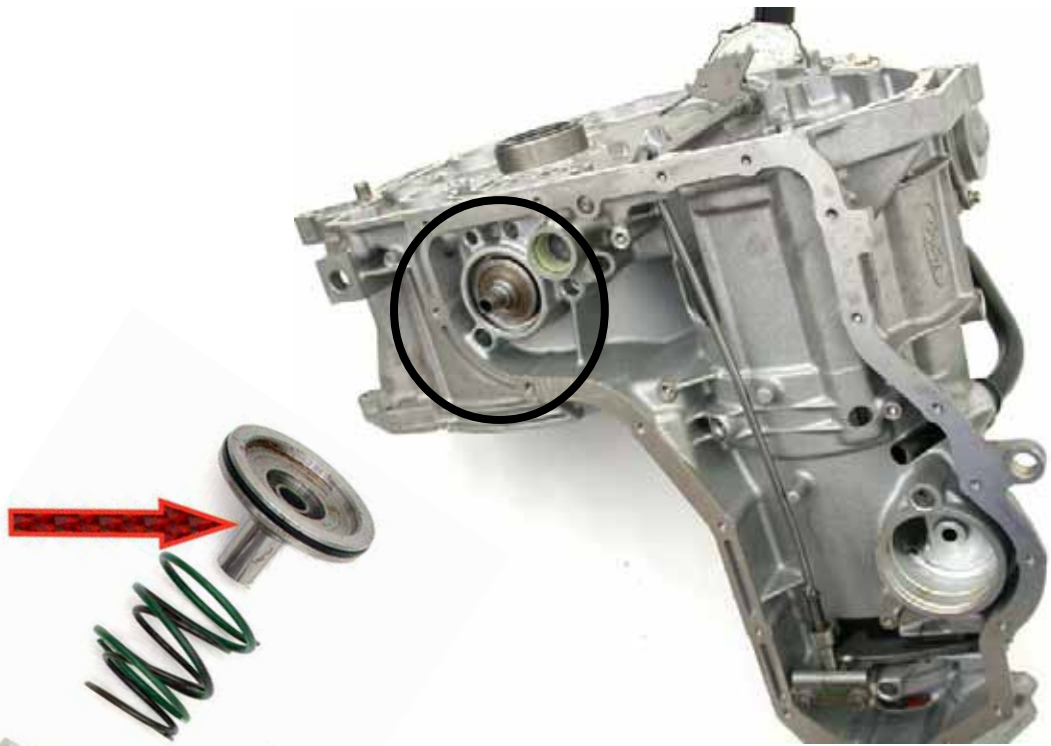
A delayed engagement may be caused by a worn or damaged neutral drive accumulator pin. The pin seals the oil between the accumulator and the forward clutch. When the pin is worn or damaged the forward clutch oil pressure is lost.

Check for wear here.

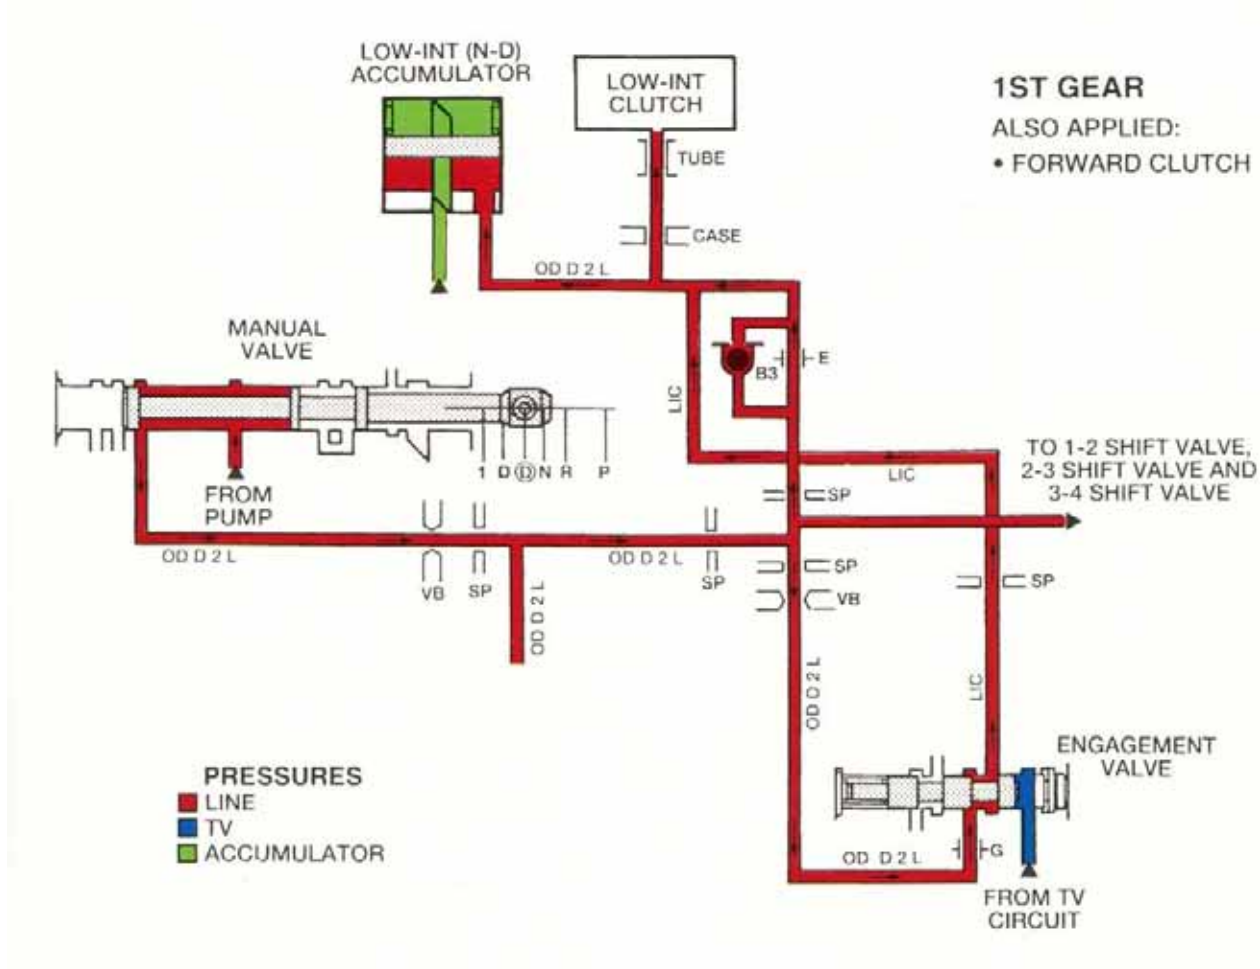
The green oil is modulated pressure from the line modulator valve. It enters the accumulator through the accumulator pin. The Red oil is line oil that comes from the 1-2 shift valve and applies the forward clutch while using the N-D accumulator to cushion the application. If the pin becomes worn it allows the line oil to enter the accumulator regulaotr circuit.

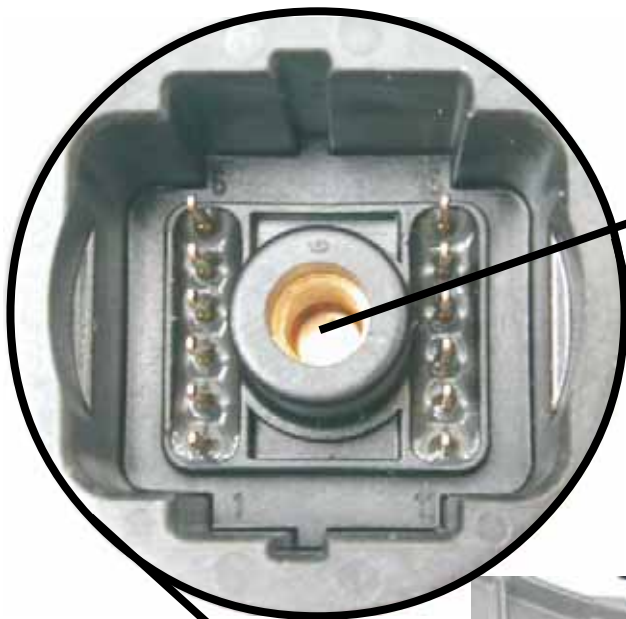
Multiple codes that won't clear may be caused by a bad or loose connection at the solenoid connector. This concern is especially found after overhaul and during the installation. The bolt on the connector has to bottom out on the solenoid block.

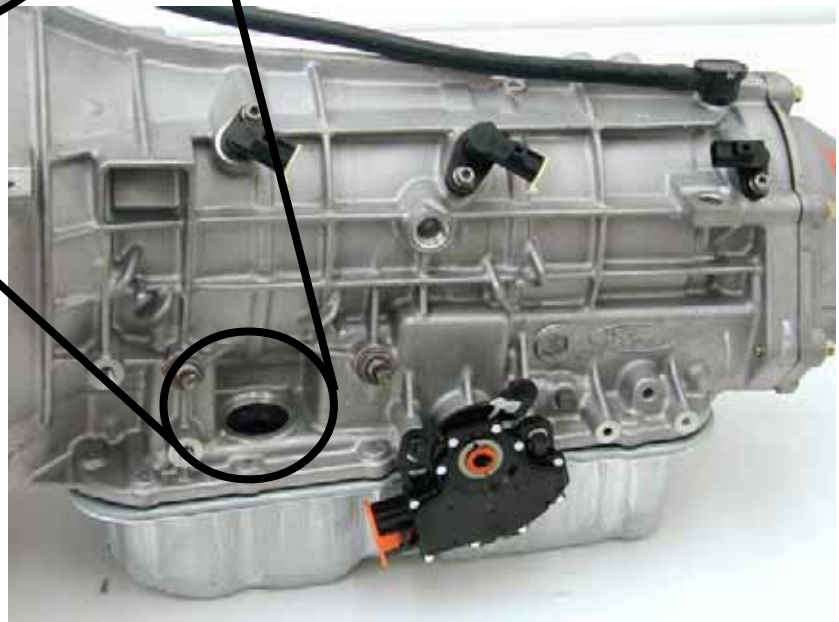
The Depth of the solenoid bolt hole is 0.470”.

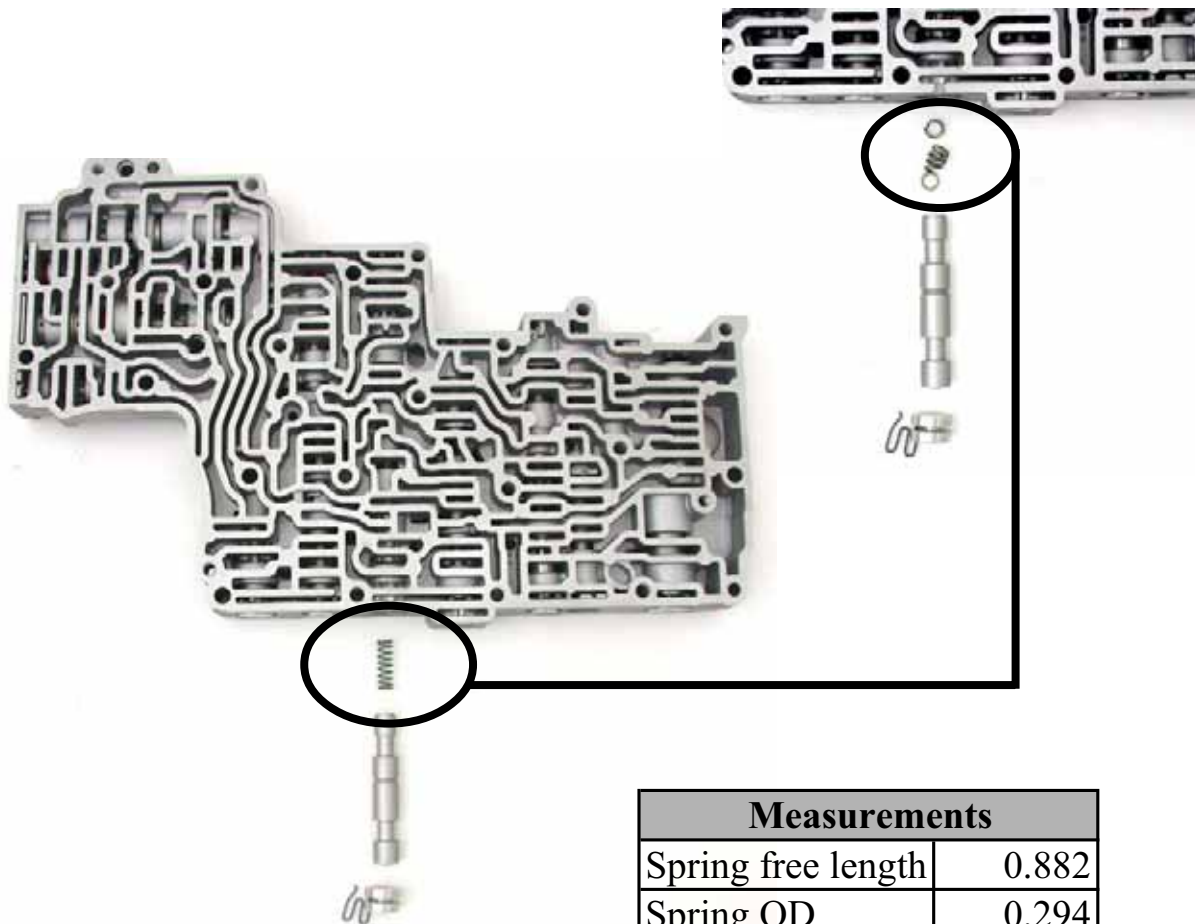
The 4-3 pre-stroke intermediate band control valve spring may break due to the spring being machined incorrectly. Also, a code P0795 (Pressure Control Solenoid C circuit failure or shorted) may be present.

Measurements	
Spring free length	0.882
Spring OD	0.294
Spring wire size	0.034

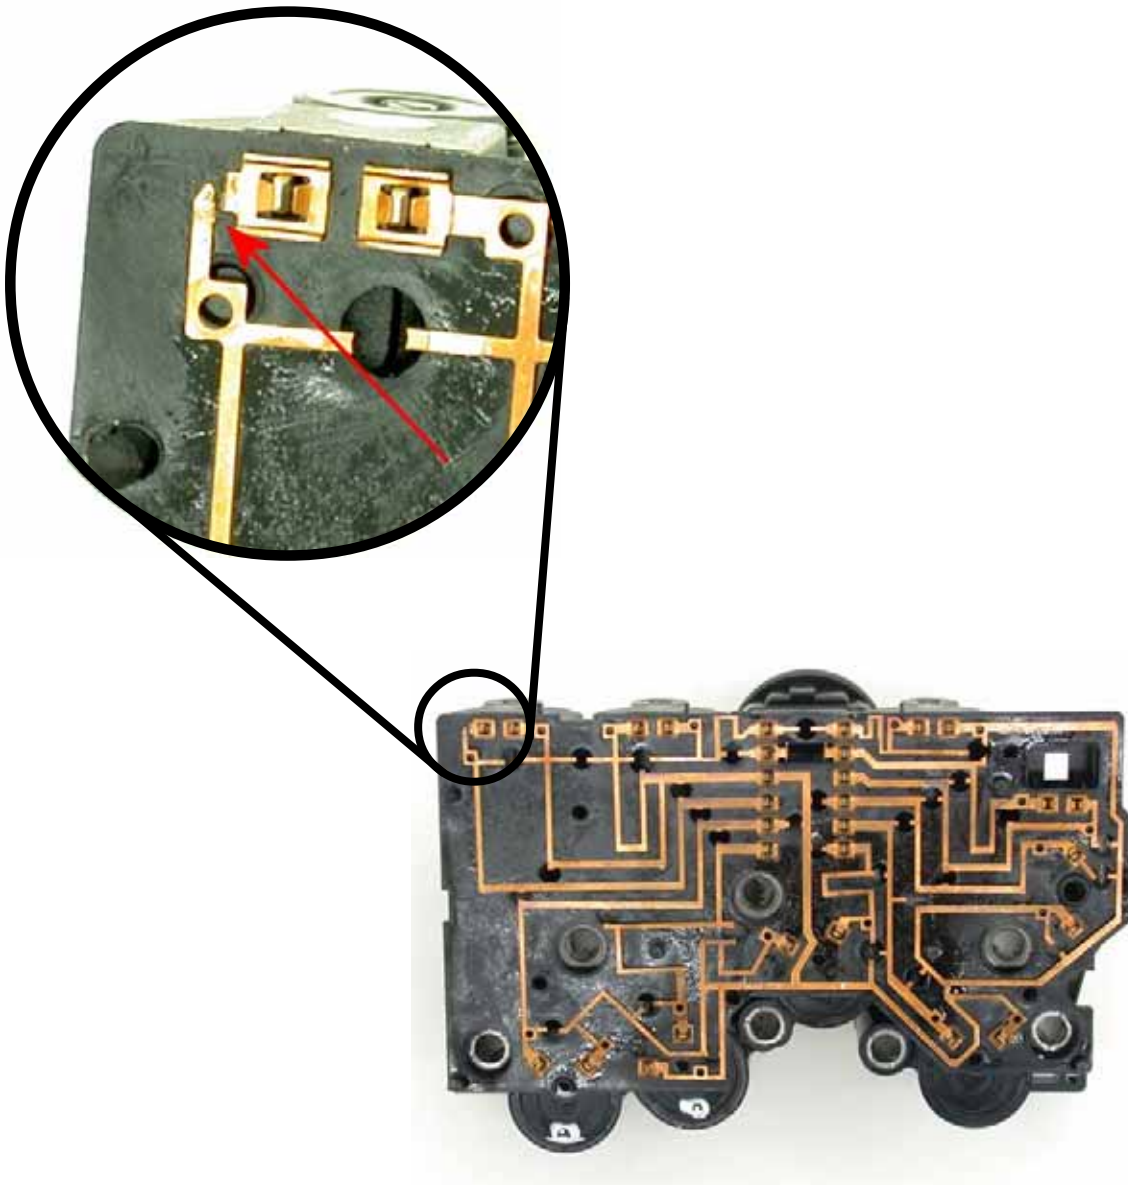
Multiple codes, with gears missing may be caused by a broken solenoid block circuit. This can be caused by the plastic housing rubbing on the circuit board.

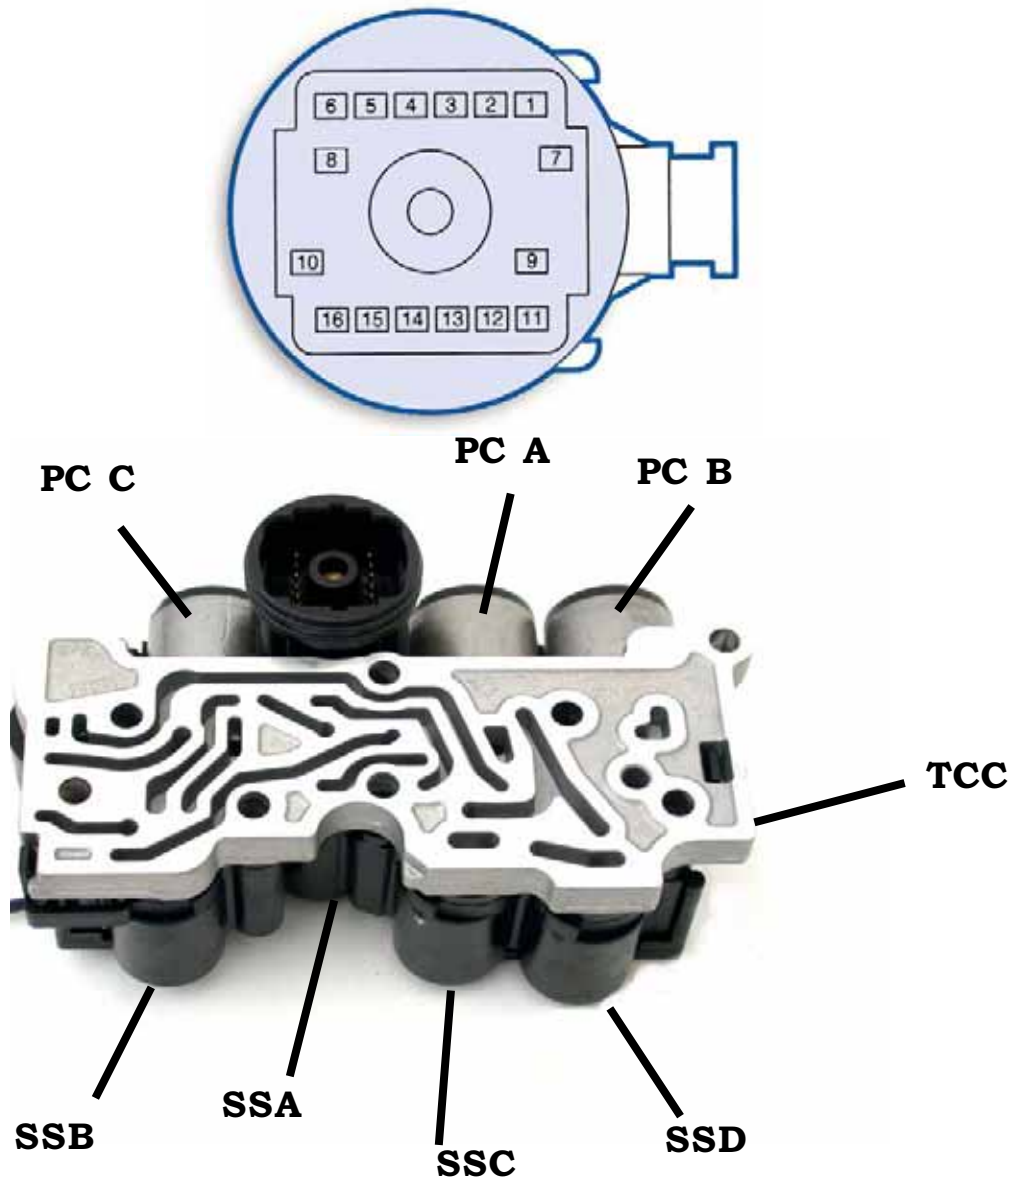
When testing the solenoids on the bench, you'll need to use the harness connector illustration on this page.

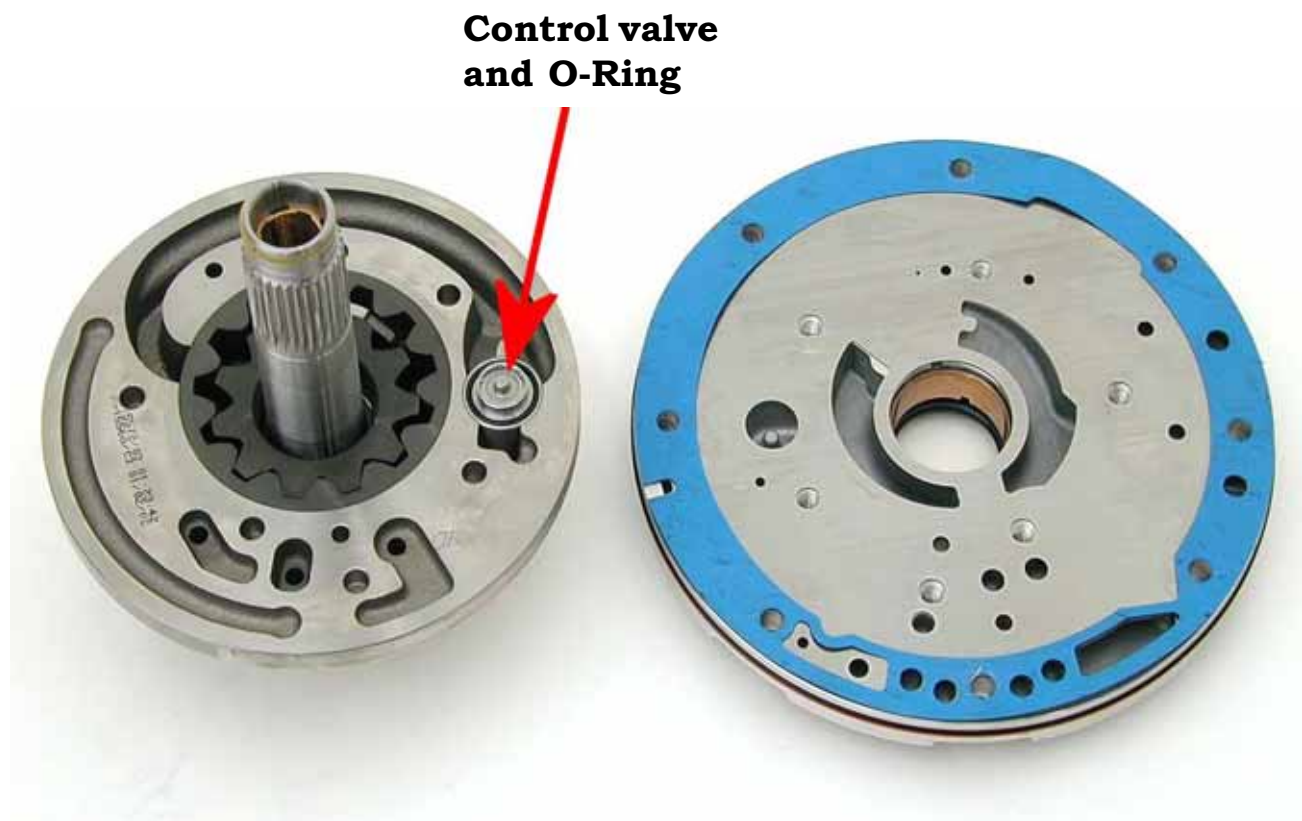
A Delayed engagement after sitting when hot or cold may be caused by the flow control valve o-ring missing, destroyed, or the control valve is stuck in the OPEN position.

The flow control valve is used to help control the volume output of the pump.

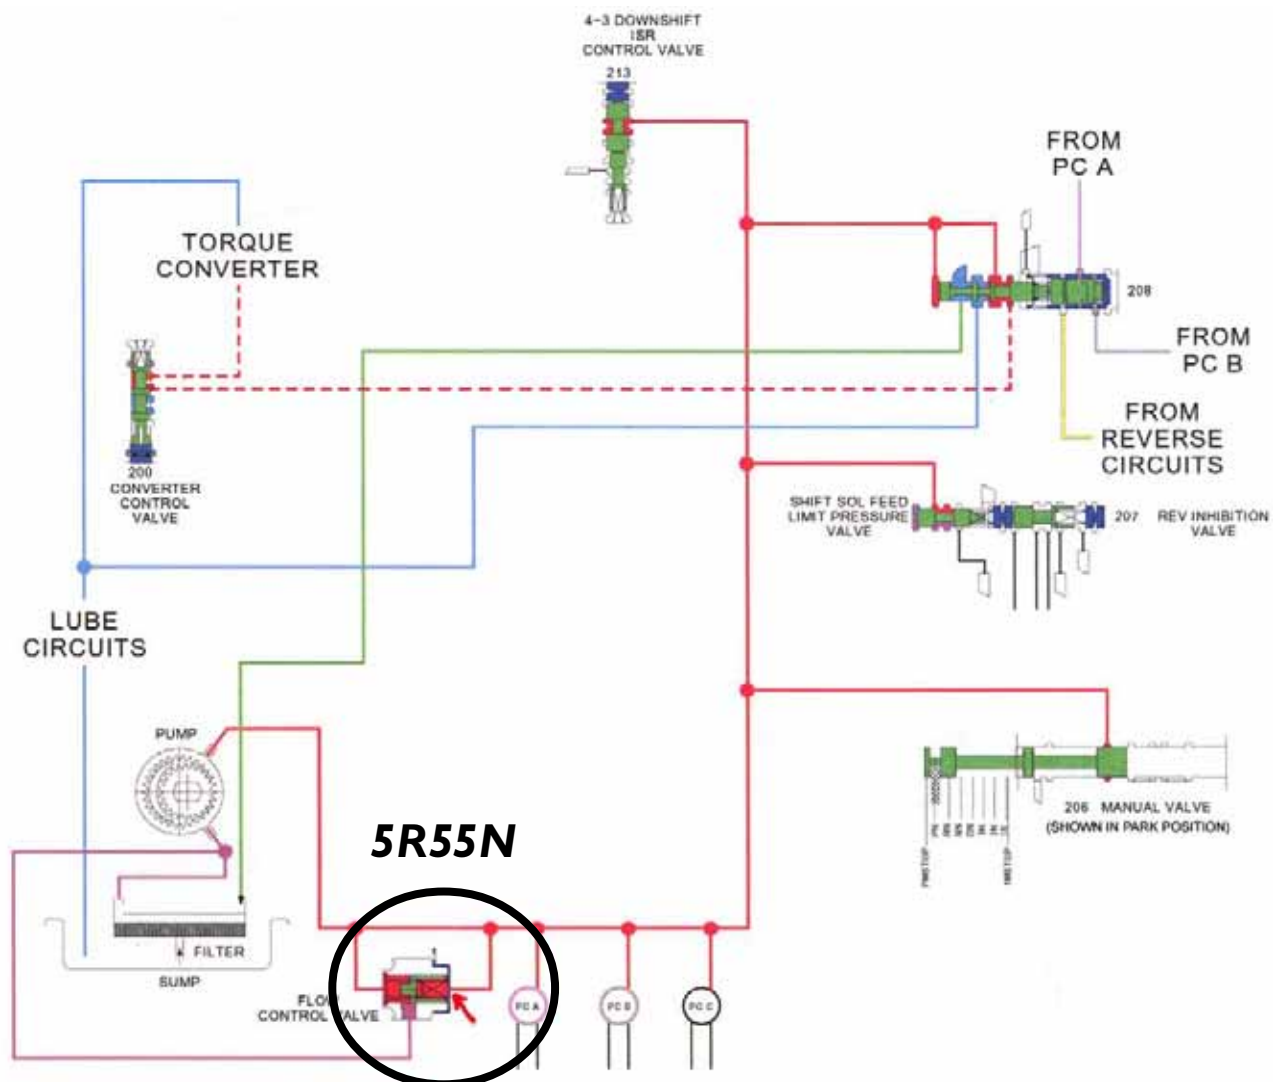
5R55N/W/S Flow Control Valve

The flow control valve works like a high pressure blow off valve. As main line oil is distributed the flow control valve is used to make sure pressure does not become excessive. If the pressure exceeds the maximum limit, the valve simply opens and allows the oil to drain back into the pump intake.

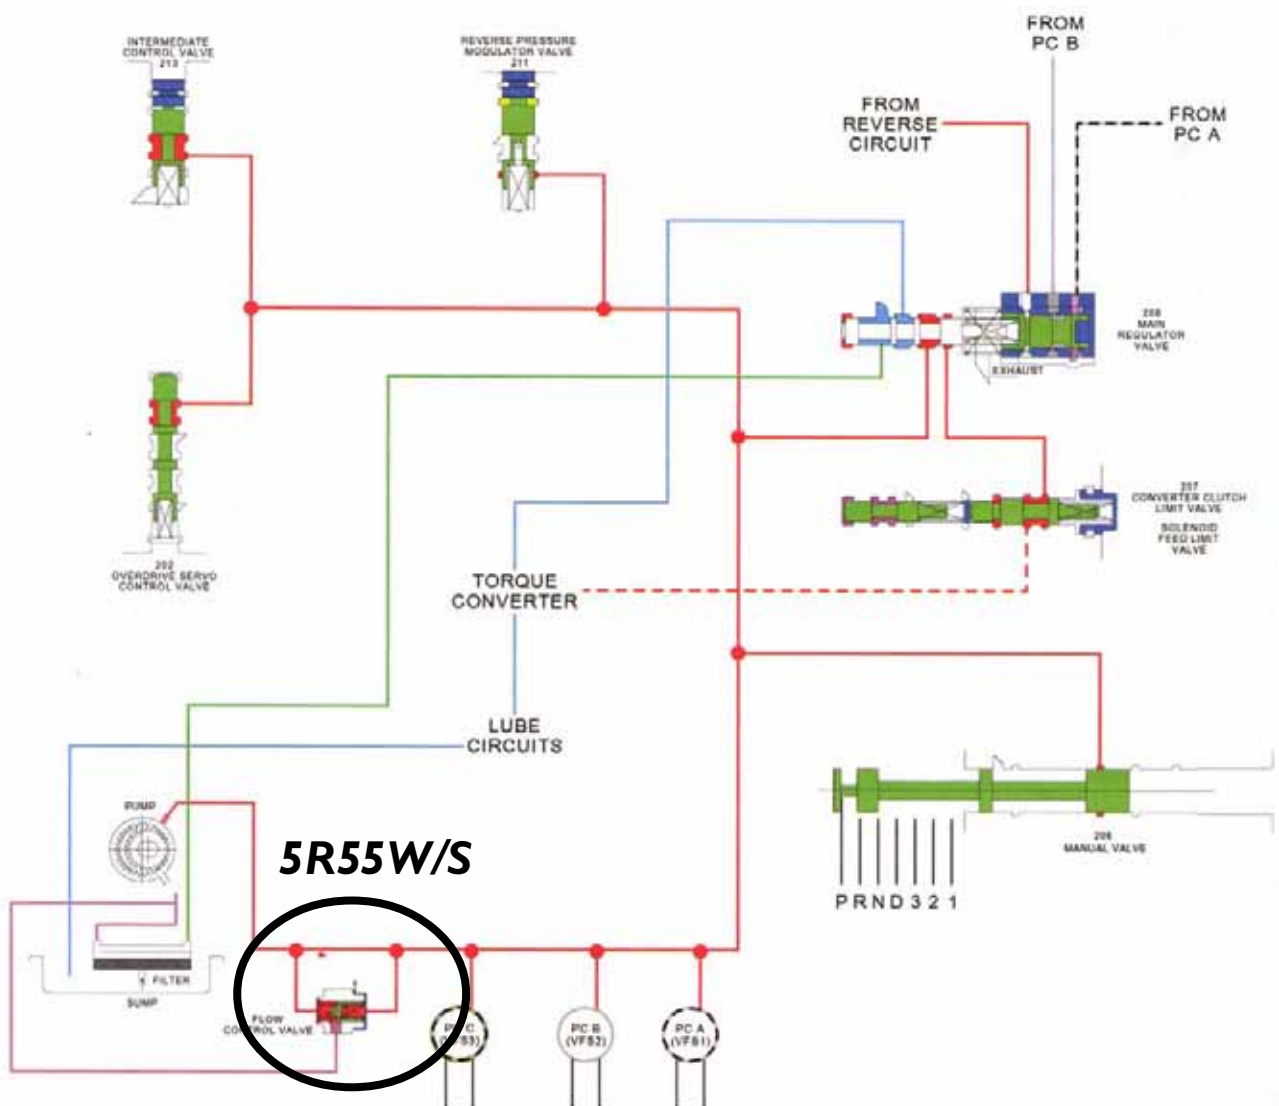
5R55W/S Flow Control Valve

The flow control valve works like a high pressure blow off valve. As main line oil is distributed, the flow control valve makes sure pressure does not become excessive. If the pressure exceeds the maximum limit, the valve simply opens and allows the oil to drain back into the pump intake.

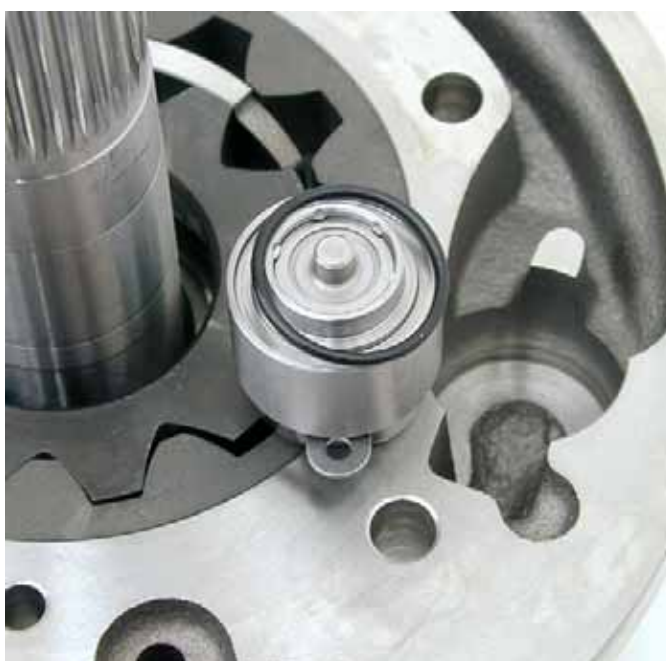
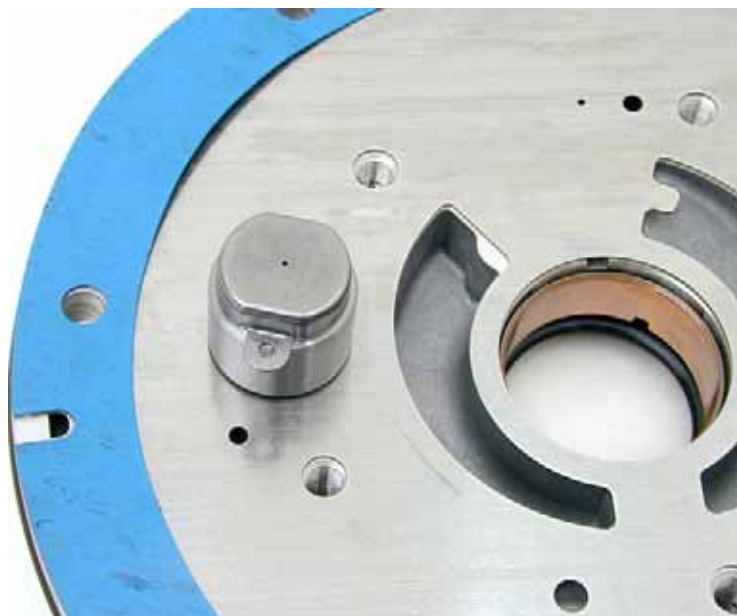
Make sure during reassembly that the oil seal is attached to the valve assembly.

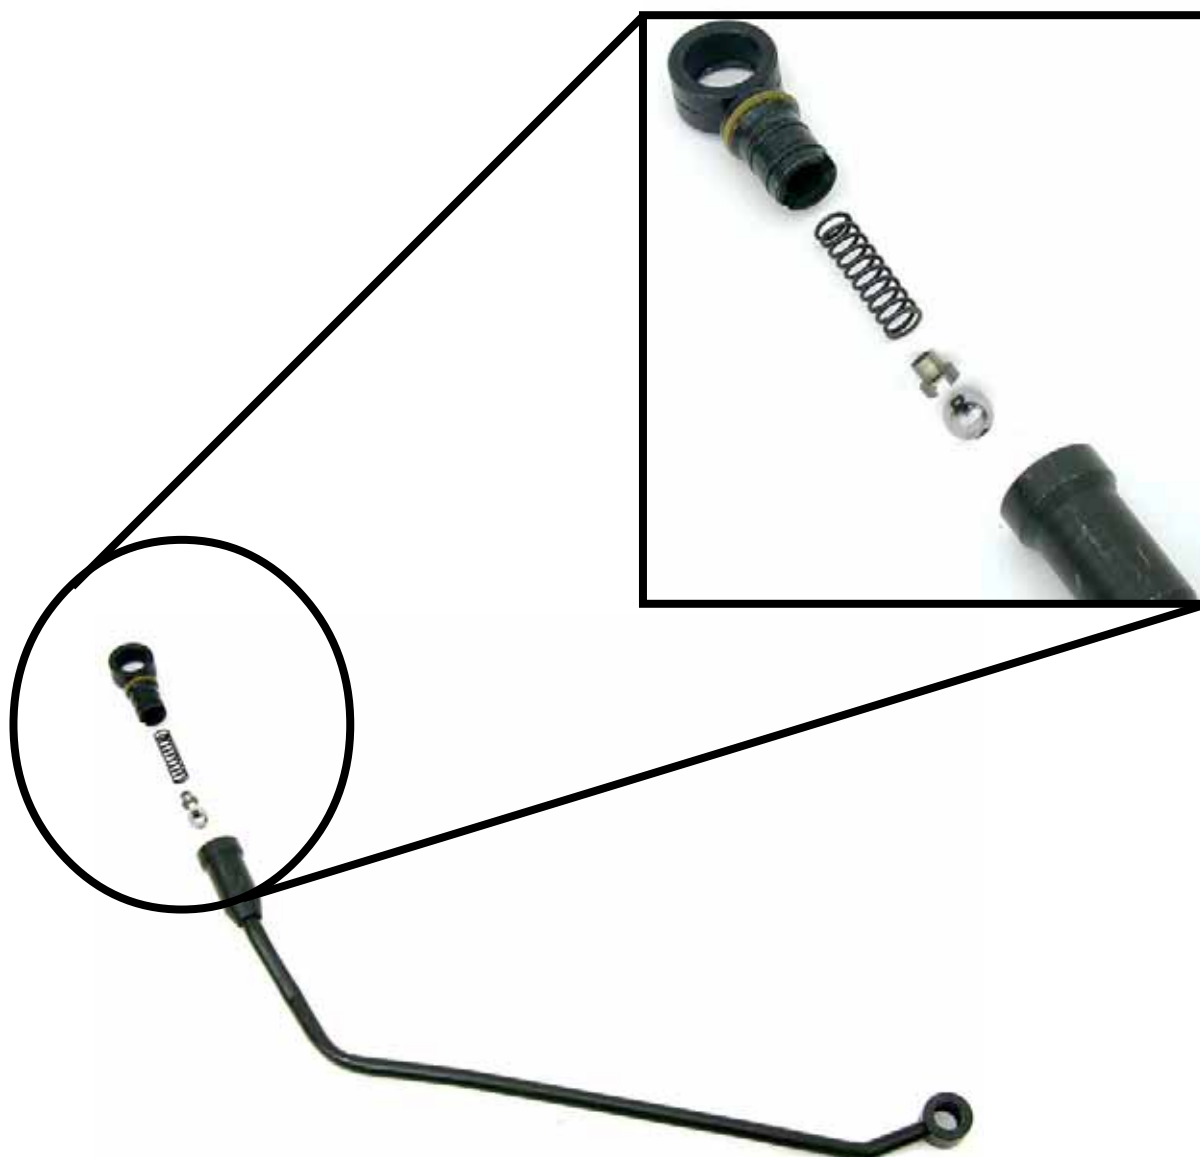
Bypass Tube

Dissassembly and re-Assembly of the bypass tube may be necessary due to heavy contamination. Simply pull the top off the cooler fitting adapter while holding the tube, and the sealed fitting will release from the tube assembly.
