# New Problems Facing the 09G

by Bill Brayton  
[www.atra.com](http://www.atra.com)

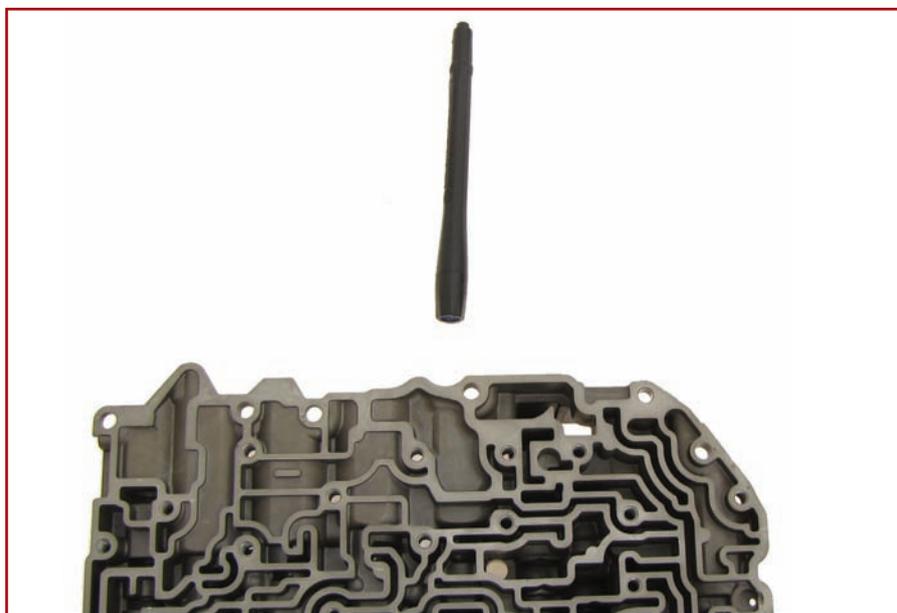
Figure 4: An inexpensive LED pen works well to shed light on worn valve bores.

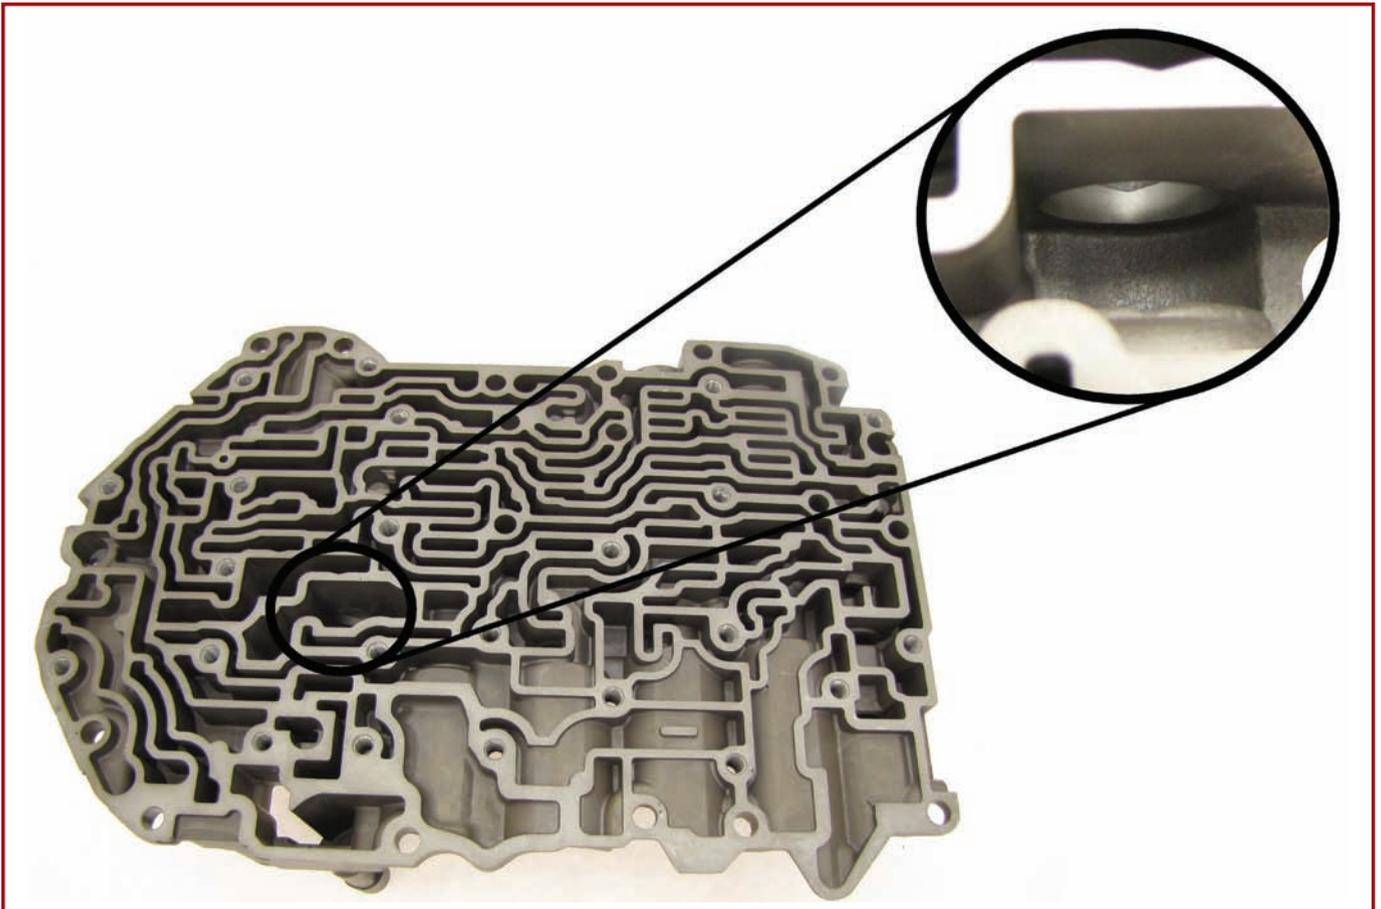
Figure 5: A dull bore is a sign of very light to no wear on a valve bore.

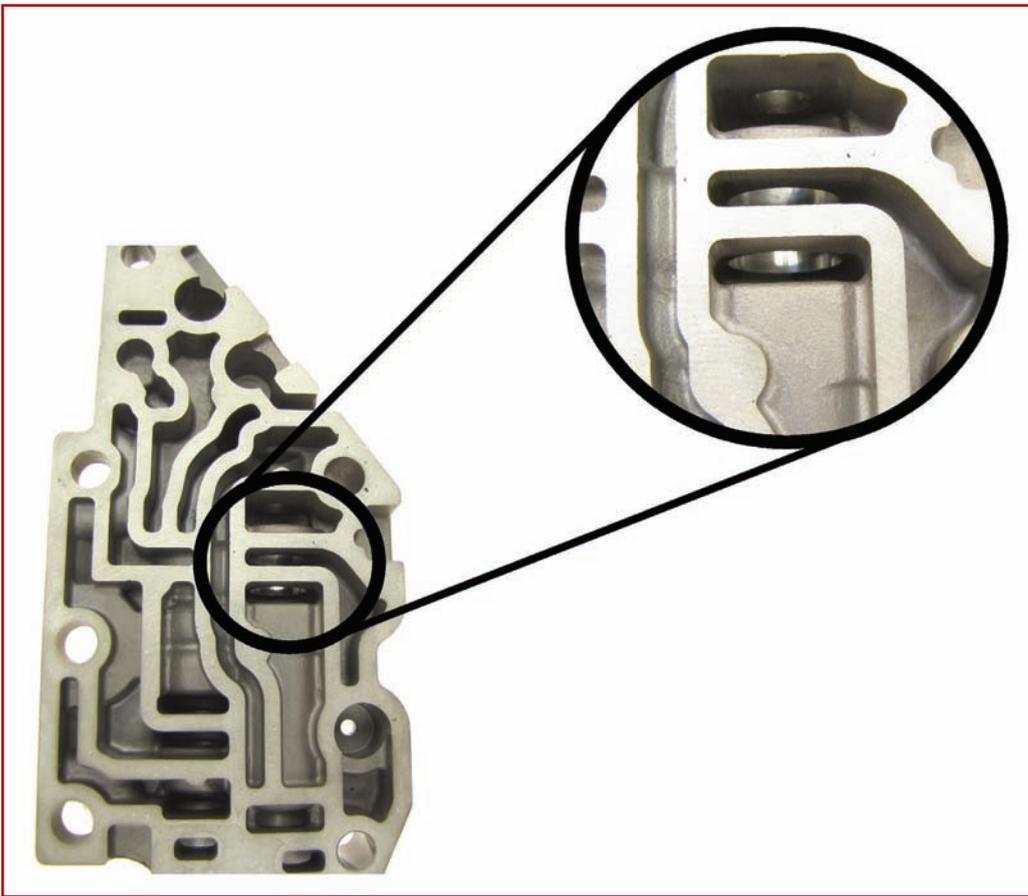
Figure 6: A shiny bore that may also have a ridge is a sign of a worn valve bore.

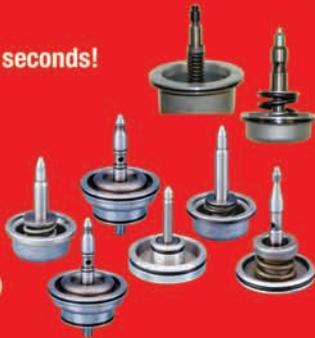
## INPUT SHAFT REPAIR KITS
