# Introducing Ford's 6R80 and 6R60

by Mark Puccinelli  
[members.atra.com](http://members.atra.com)

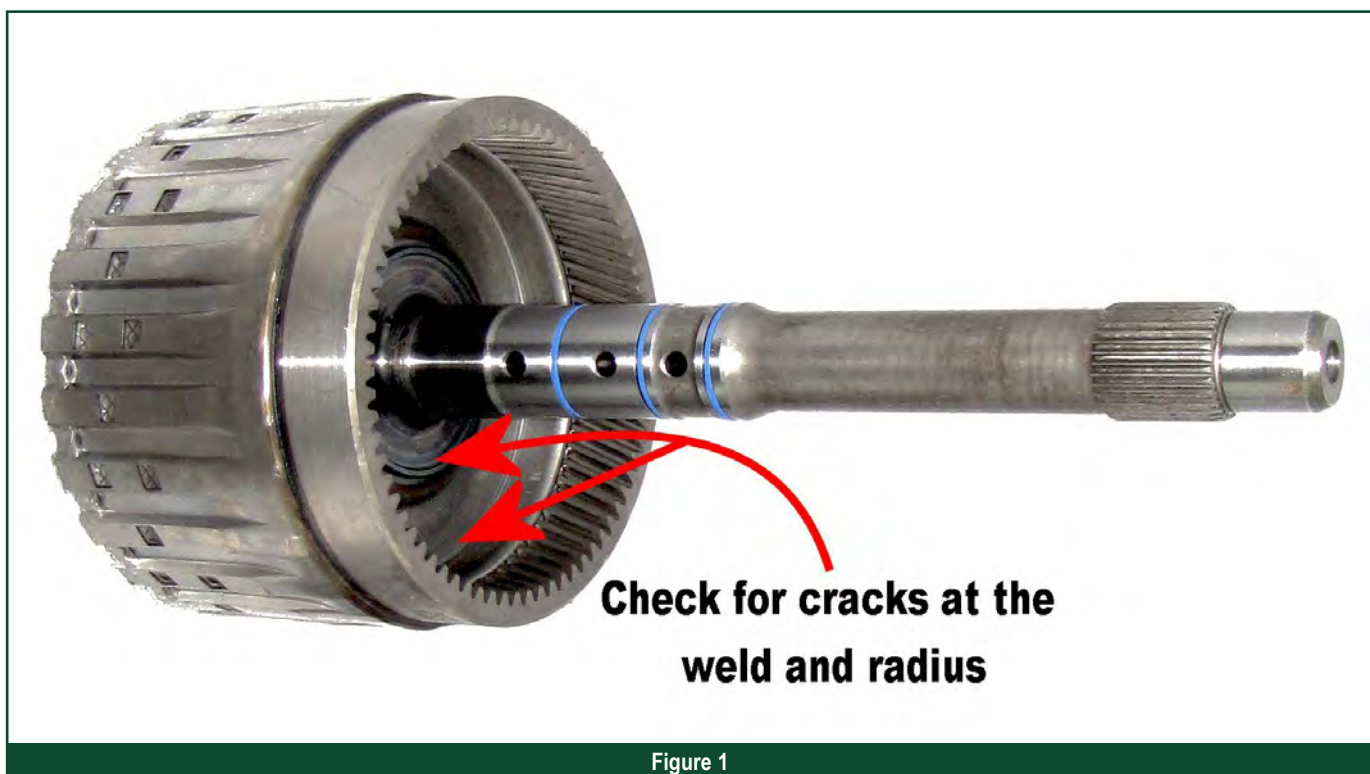
Figure 1

The E clutches, drum, and stator support bushings tend to present problems in these transmissions. When the E clutch or drum fails, it can cause shift complaints and codes in fourth, fifth, and sixth. Always check the drum for cracks at the weld and the internal radius (figure 1).

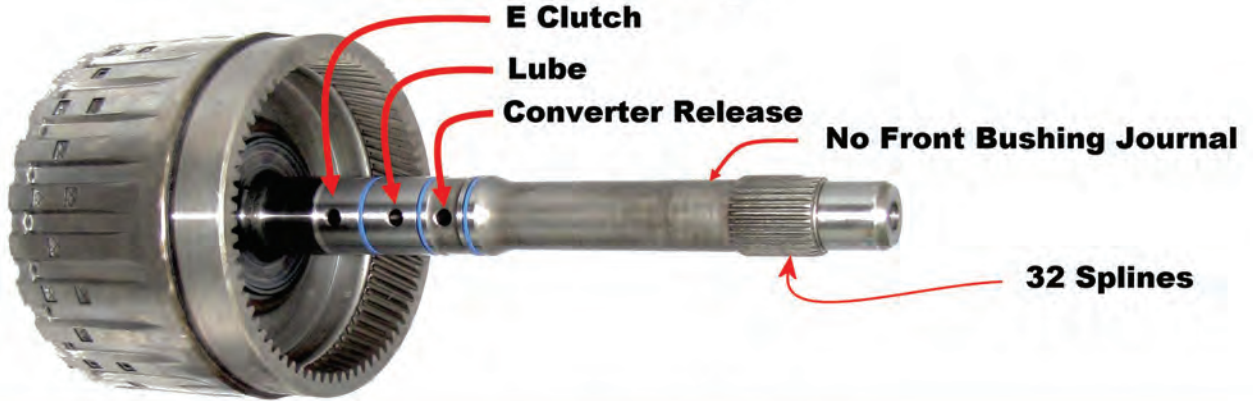
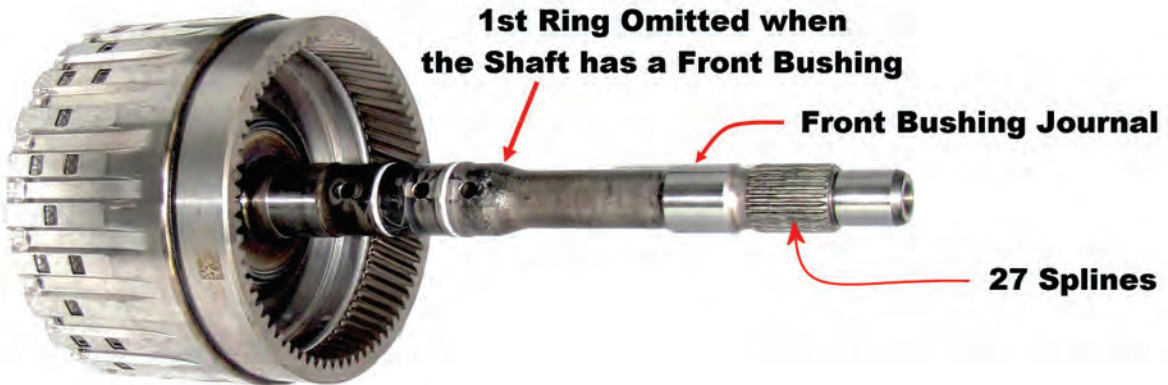
Figure 2

The E drum will have either two

or three sealing rings (figure 2). The three-ring drum doesn't use a front stator support bushing; the two-ring drum does (figure 2 & 3). All drums and pump covers have a rear stator support bushing. The stator support bushings and shafts come in different journal diameters, 6R80 09-up have 32 splines and 6R60/75 06-up have 27 splines, and turbine spline count can vary.

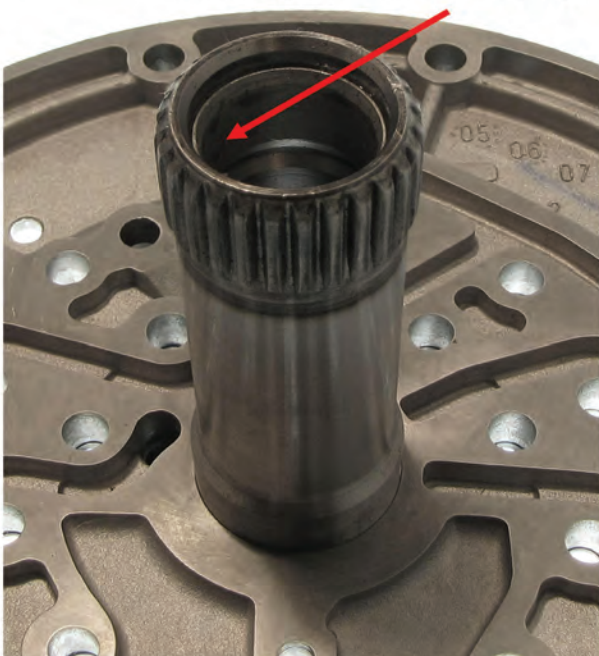
Figure 3

## Bushing for 6R60/75 06-Up

The two-ring drum uses the front stator bushing to seal the converter clutch release oil circuit. If the front stator bushing has excessive clearance it can lose torque converter clutch release pressure. This may cause the

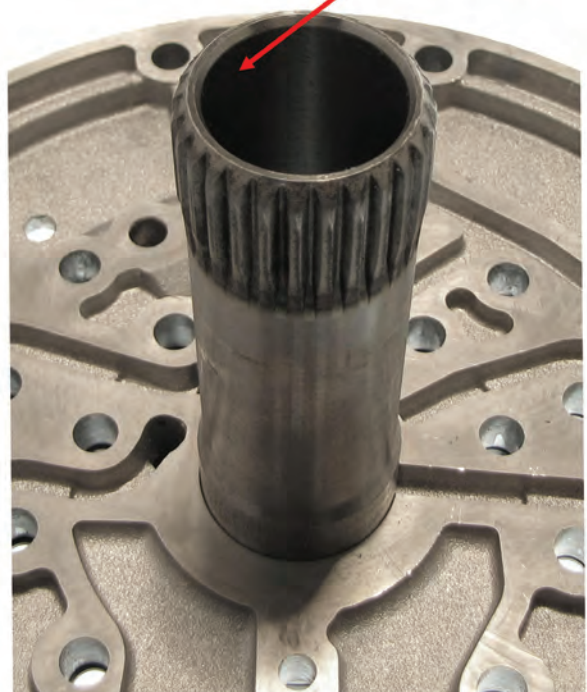
Figure 3A

## No Bushing for 6R80 09-Up

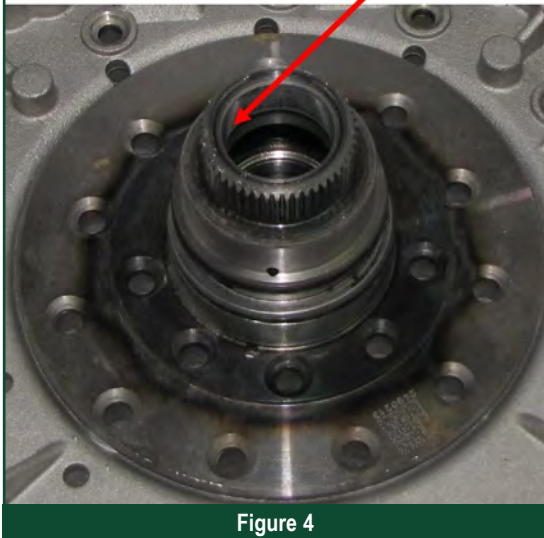
Figure 4

**The rear stator bushing serves as the seal for the E clutch circuit on both two- and three-ring shafts. With the bushing providing the seal, bushing to shaft journal tolerances become critical.**

The rear stator bushing serves as the seal for the E clutch circuit on both two- and three-ring shafts. With the bushing providing the seal, bushing to shaft journal tolerances become critical. Excessive rear stator bushing clearance can cause the E clutch to slip and set codes in fourth, fifth, and sixth gears (figure 4).

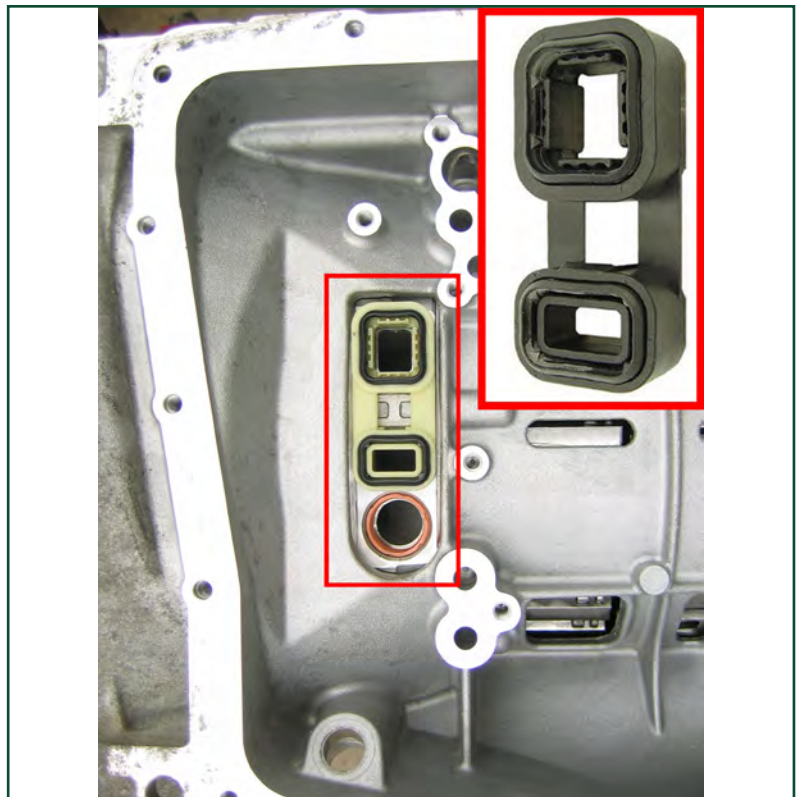
Figure 6

The bridge seal between the valve body and pump is known to blow out. This can cause a variety of low line pressure symptoms, delayed engagements, or cause the transmission to fall out of gear. These symptoms generally come with gear ratio or solenoid performance codes.

Start by confirming the transmission fluid level is correct. Make sure the control module has the latest programming. If the pan and fluid are clean, remove the valve body and inspect

the bridge seal (figure 6).

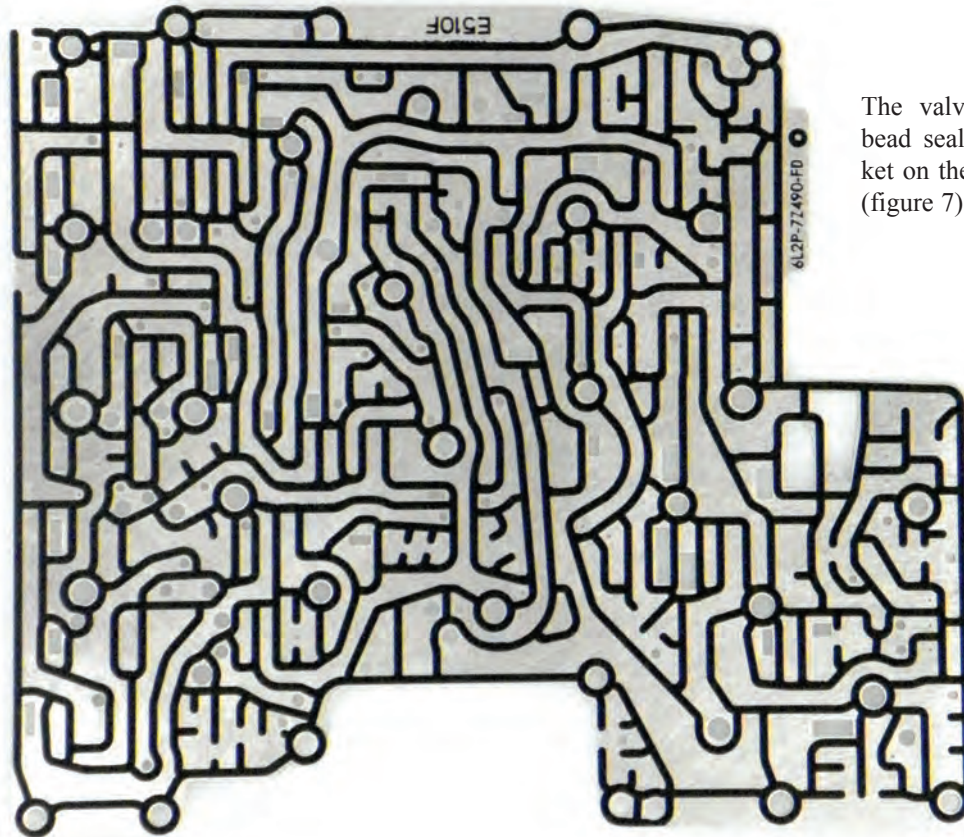
Figure 7

The valve body uses a bead seal laminated gasket on the separator plate (figure 7). Always replace the separator plate during valve body repairs to avoid leaks. Most suppliers stock replacement separator plates.

The valve body uses a bead seal laminated gasket on the separator plate (figure 7).
