# VALVE BODY PROBLEMS with Toyota's

by Pete Huscher members.atra.com

U660E, U660F, U760E, and U760F

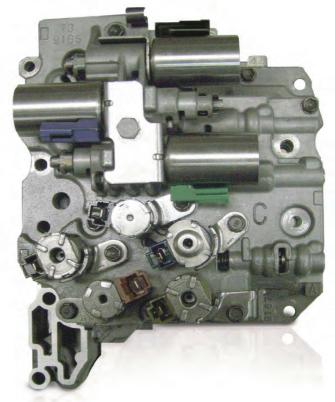
Erratic shifts, lockup problems, and burnt clutch components may be caused by worn valve body end plugs (figure 8). Worn OEM end plugs may allow line pressure and SLT pressure to leak from around the valve body bores. Installing

O-ringed end plugs during every valve body repair should correct these problems.
