# **Technical Seminar 2002**

# *Automatic Transmission Rebuilders Association*

# Ford

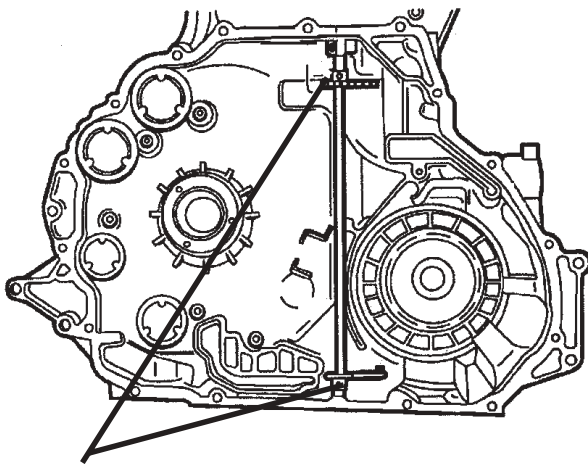
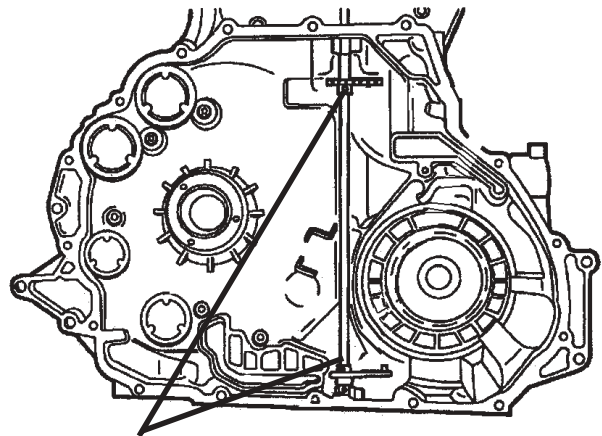
The positions of the roll pins changed

Redesigned plate uses an additional bolt.

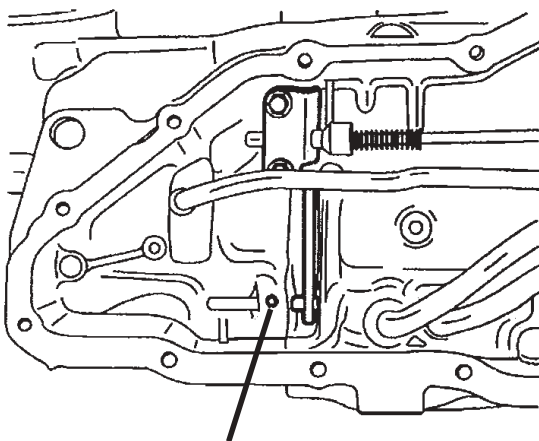
Roll pin.

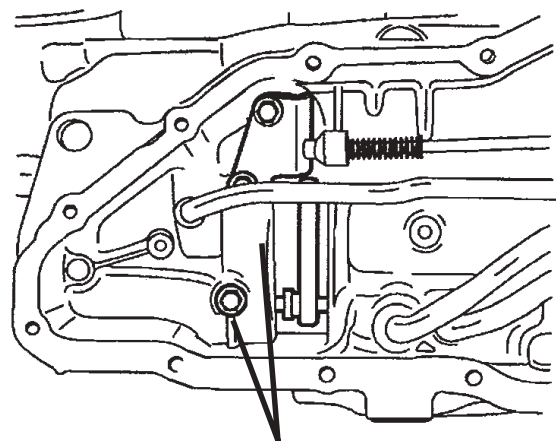
Bolt and Plate assembly.

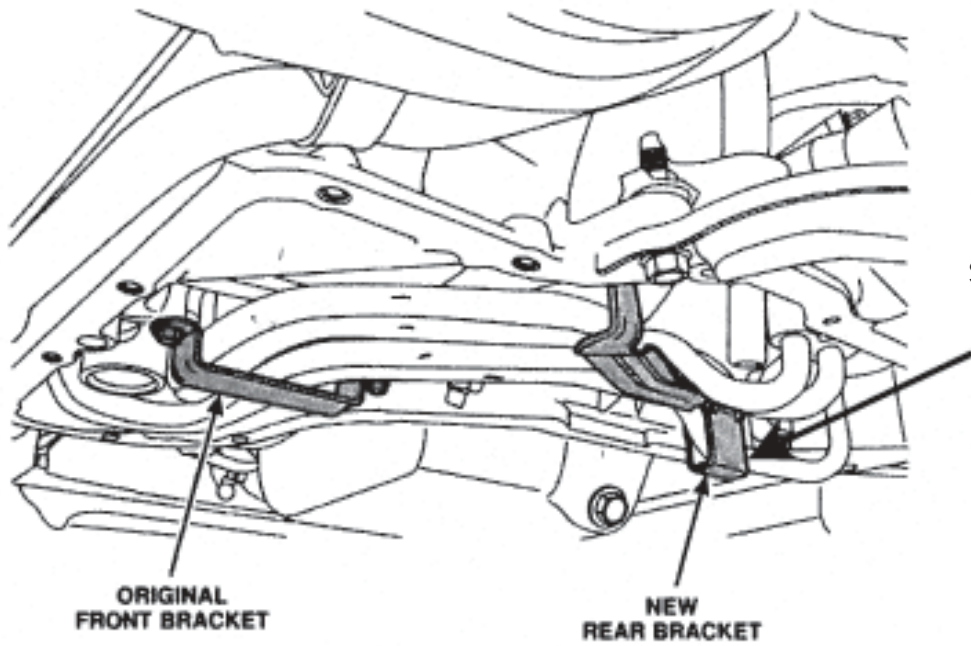
**Cause:** A loose fit of the tube to the case assembly allowed the tube to vibrate and move, causing it to crack at the stub area.

New bracket support for the lube tube

Area that cracks

**Repair:** Replace with redesigned tube and rear bracket. FORD part number 1F1Z-7G353-AA

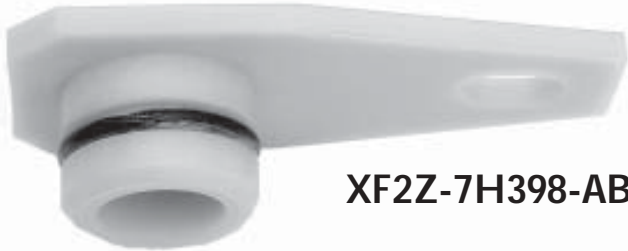
XF2Z-7H398-AB

*AX4S 1991-1999 also needs plug for speed sensor*

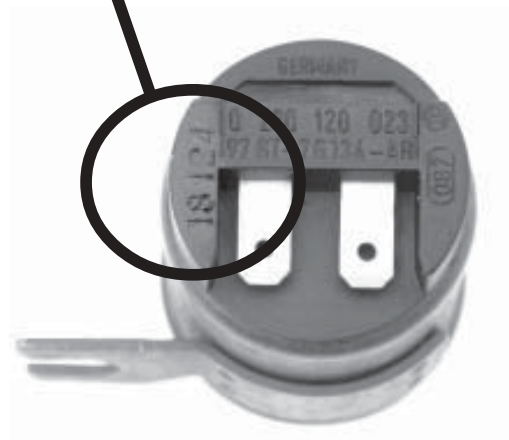
Lot number location

**Common Cause:** TCC solenoid (there were certain TCC solenoids that were poorly designed and the result was the tip blowing out and the brackets were cracking).

**Note:** *Make sure not to reuse lot numbers between 769 and 771, these solenoids are defective.*

**Repair:** Replace solenoid.

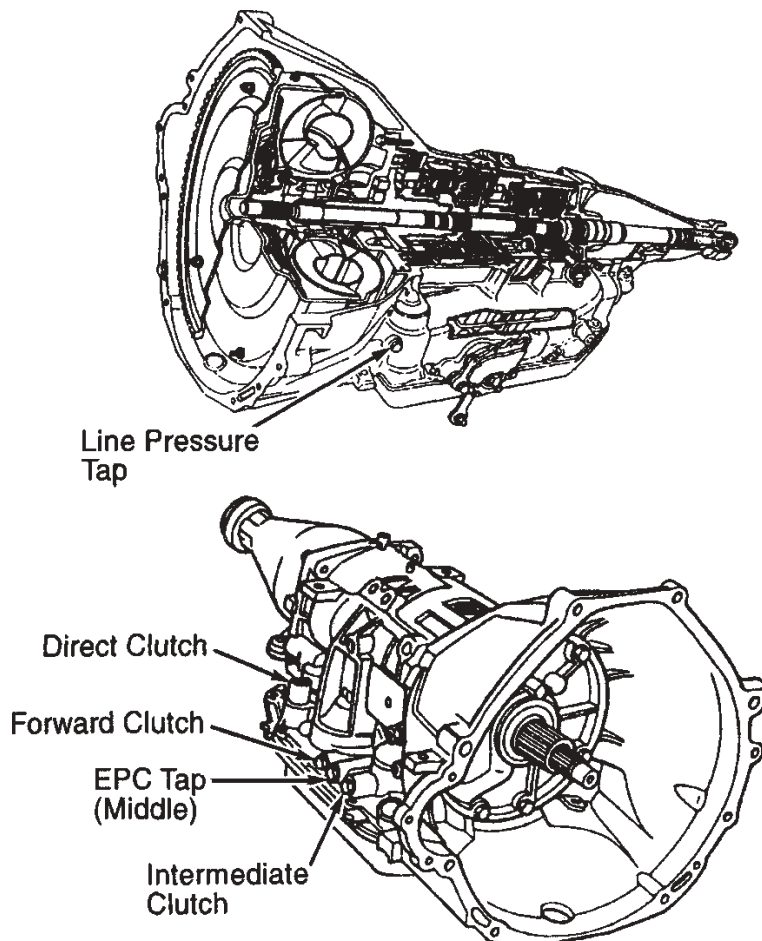
**Common Cause:** The 3/4 shift valve strokes cutting off the forward clutch. Restricted solenoids being the most common concern are the focus of our attention, but keep in mind that it is the flooding of the solenoids that causes the neutralization so anything that can cause a solenoid to flood is also of concern.

**Testing & Repair:** Install a gauge on the forward clutch pressure tap. When the neutralization occurs, if the gauge reads at or near 0psi, replace the shift solenoids and inspect the solenoid pressure regulator valve and bore for wear.

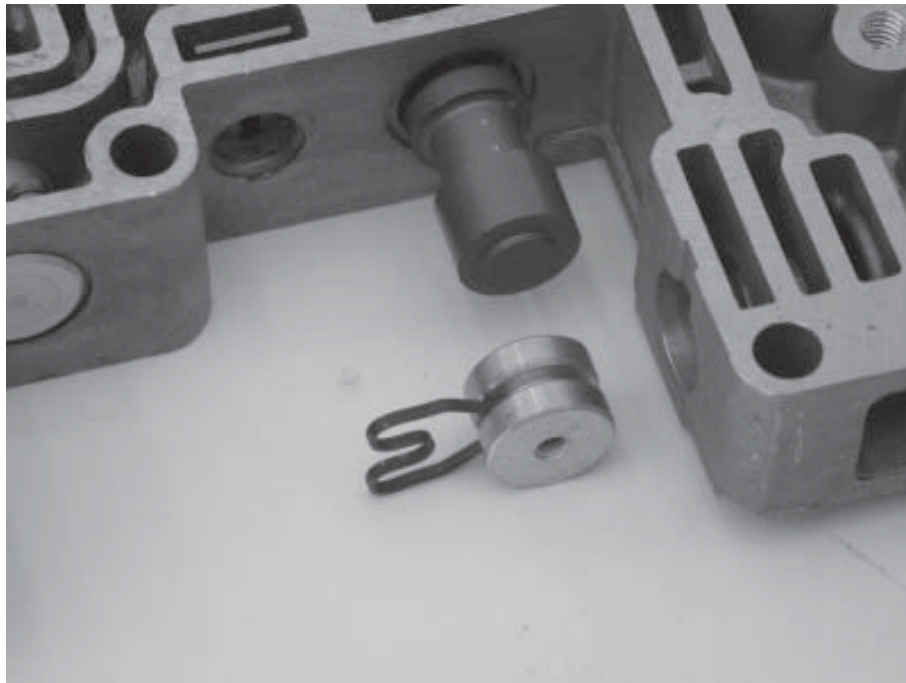
**Common Cause:** 2/3 shift valve end plug leaking. This leak causes the direct clutch to be cut off due to the amount of solenoid oil pressure required to keep both the 3/4 shift valve and the 2/3 shift valve in the stroked position. Because the 2/3 shift valve has only one area for solenoid pressure to pin the valve versus two for the 3/4 shift valve it is more likely to be susceptible to the leak.

**Testing & Repair:** Install a pressure gauge on the direct clutch tap. When the transmission neutralizes if the gauge shows little or no pressure, then remove the 2/3 shift valve end plug and run a tubing cutter around the outside diameter to seal the leak.

**NOTE:** While performing this repair also check the 2/3 shift and solenoid pressure regulator valves and bores for wear.

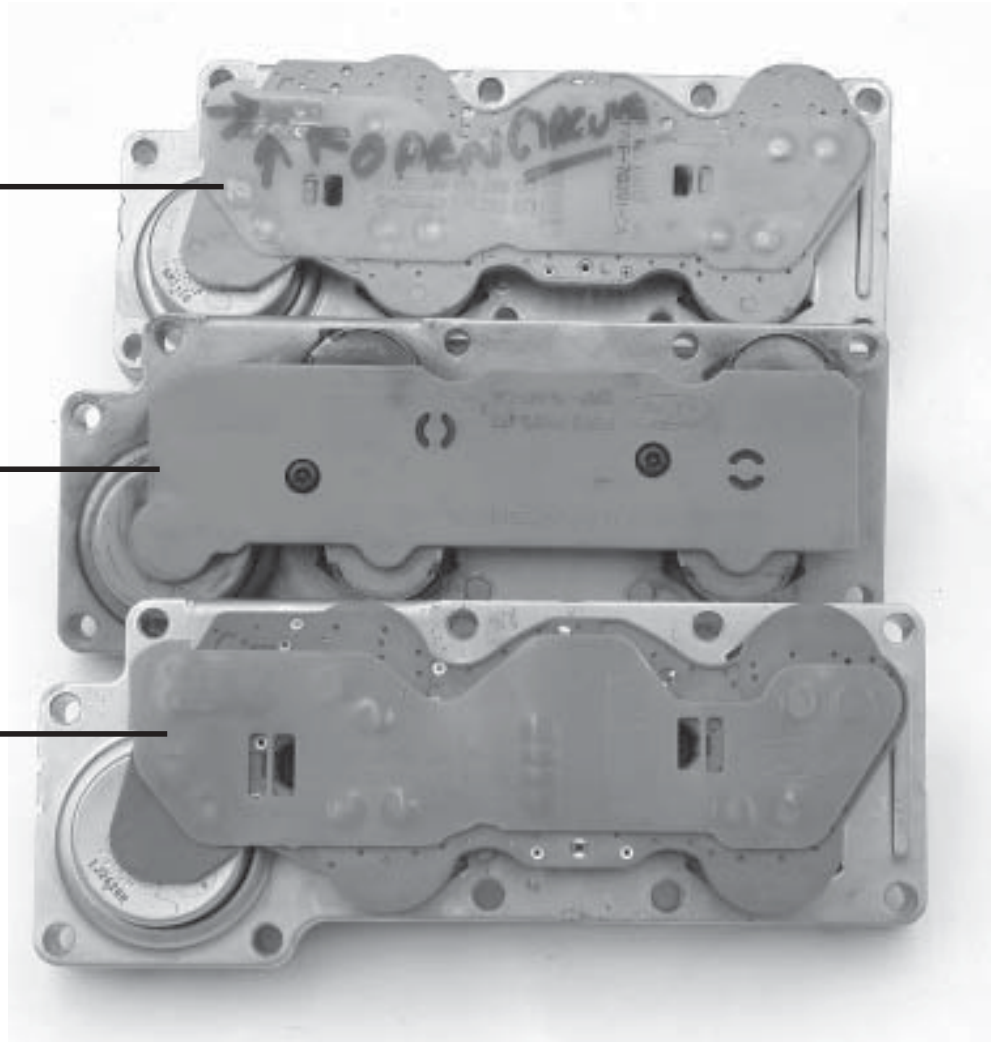
- The second design PWM solenoid body has a GREEN top cover and a screen for the PWM circuit. However, this solenoid body caused a 2-3 and 3-4 shift flare with marginal fluid capacity at the PWM solenoid. The PWM solenoid and PCM calibration had to be updated.  
**Note: This change resulted in the third design replacement solenoid body! (Do not use the second design solenoid body)**

- The third design replacement solenoid body has an Orange top cover.  
**Note: This solenoid body has a screen!**

New PWM  
Orange  
cover  
Part number  
F81Z-7G391-CB

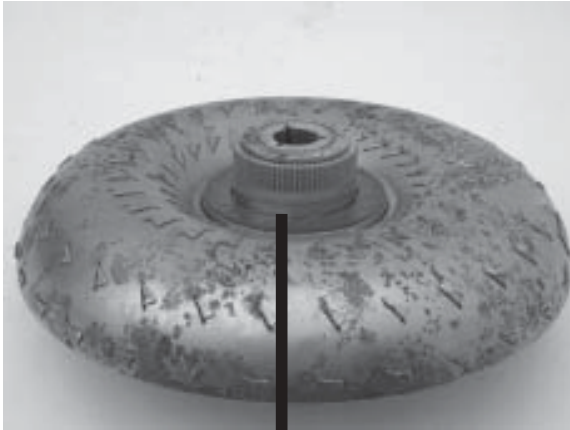
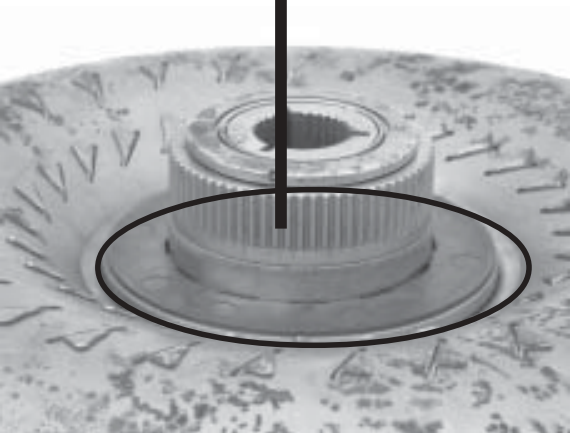
*Old*

With sealing ring  
on turbine hub

**Repair:** Replace Torque Converter with Part# XL3Z-7902-DARM

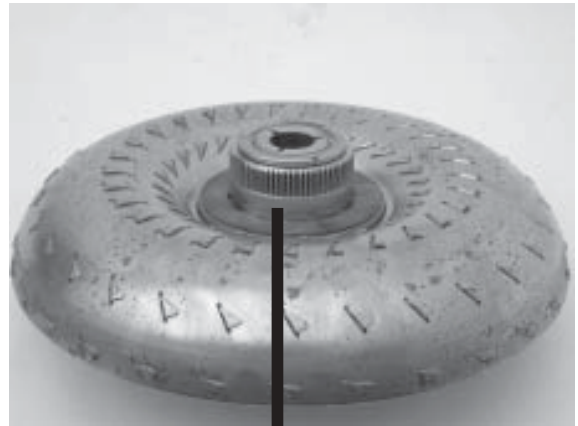
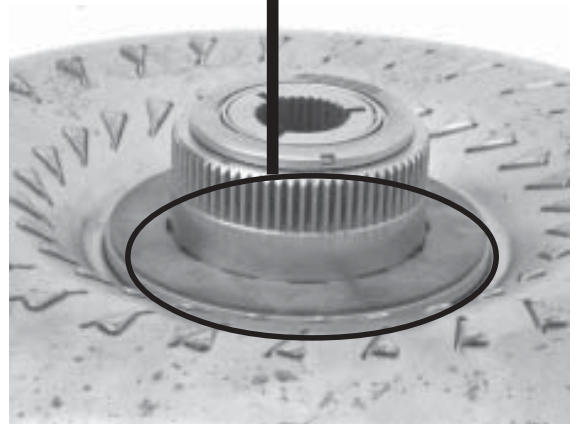
*New*

**NOTE:** Replacement converter comes with a two piece apply piston

Without sealing  
ring on turbine hub

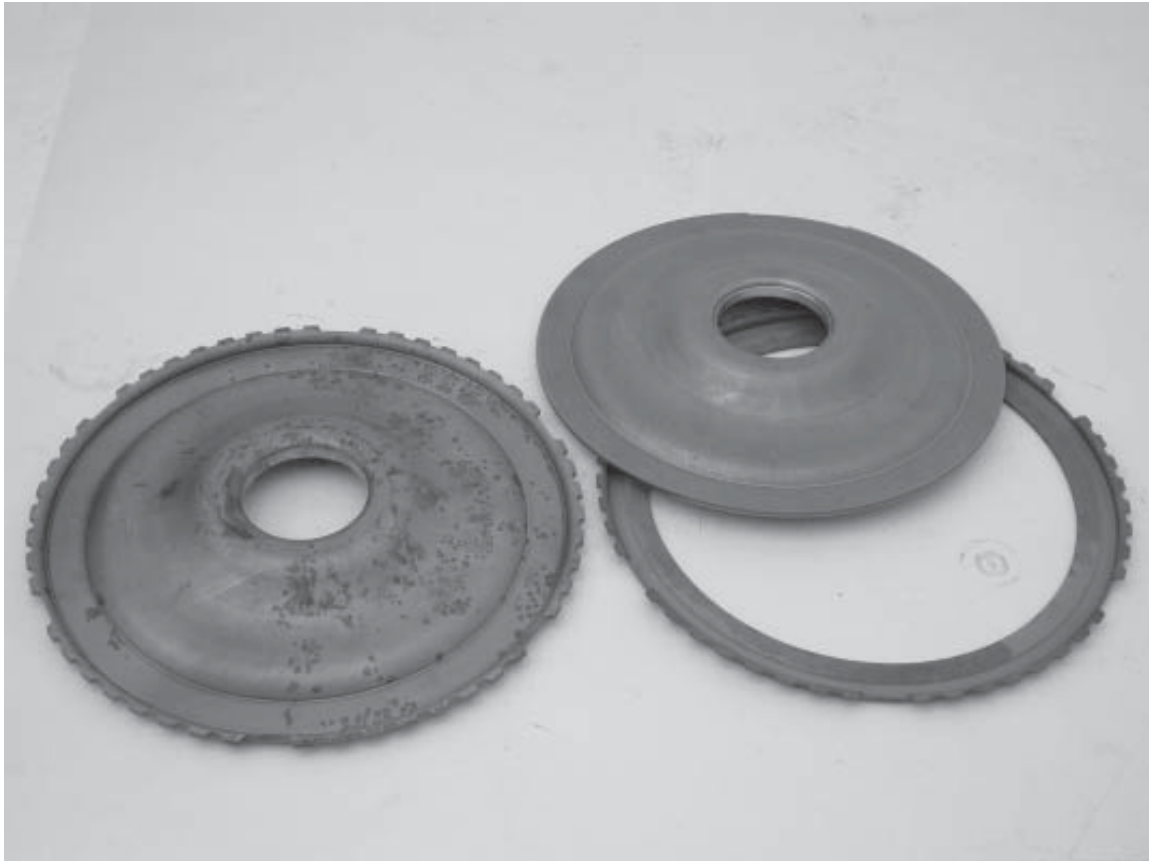
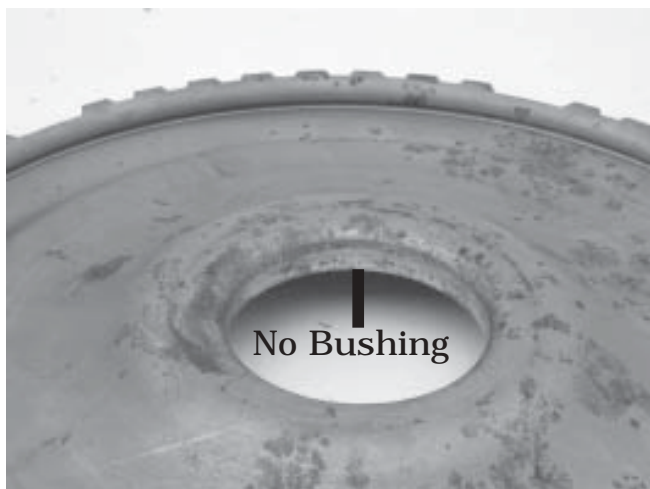
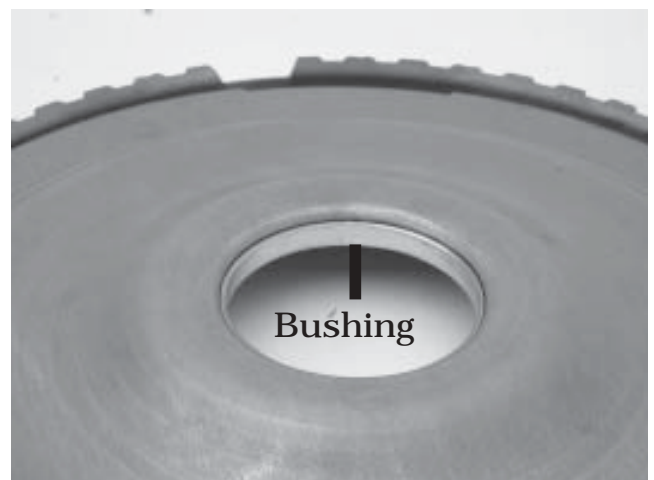
**Common Cause:** The impact between the outer lugs at the converter piston and the cover. To confirm this problem you can command the torque converter on from the computer or test it at the transmission.

New converter has a two piece apply piston.
